Lifecycle Assessment Report

The Lake at Heritage Pointe Owners Association

Heritage Pointe, Alberta

Report No. 2300676.00

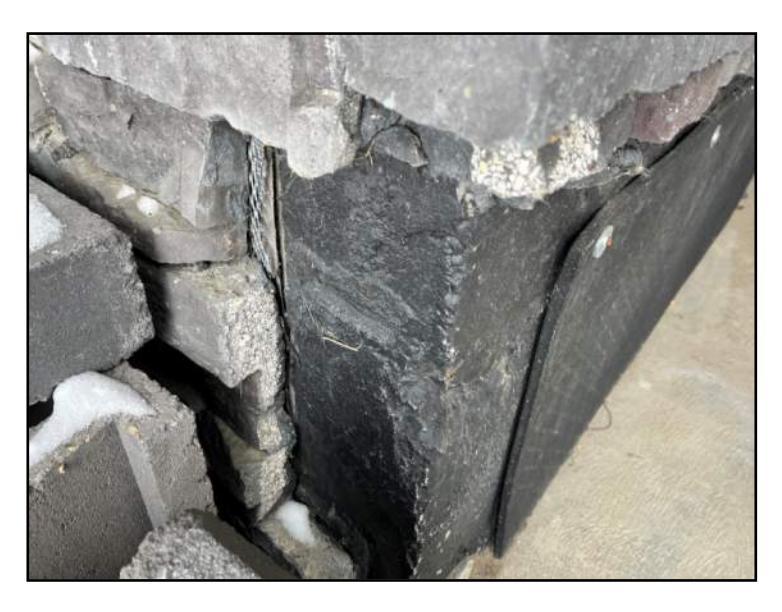
We noted normal, isolated, fine cracking. Evidence of major settlement or heaving of the foundations was not reported or observed.

Photo 2.1.1.1-1 Concrete foundation wall at Lake House

The foundations and foundation walls are expected to last the life of the building with isolated repairs only. Major capital expenditures are not anticipated to be required.

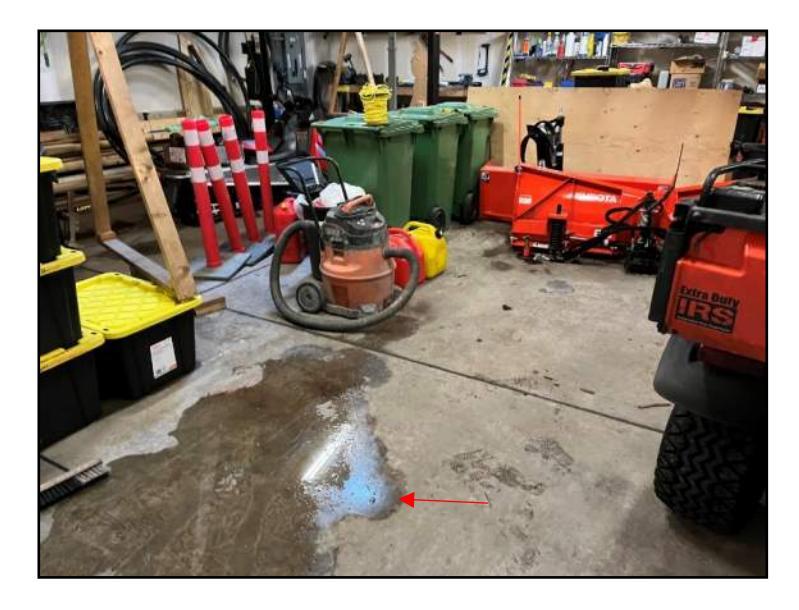
Where the slabs were exposed, we noted normal, isolated, fine cracking. At the garage, ponding water was noted at the area between the overhead doors. It was reported that this is due to snow melting off of the snow removal equipment that is stored in the garage. No evidence of major settlement or heaving of the concrete was reported or observed.

Photo 2.1.1.2-1 Ponding water at garage slab on grade

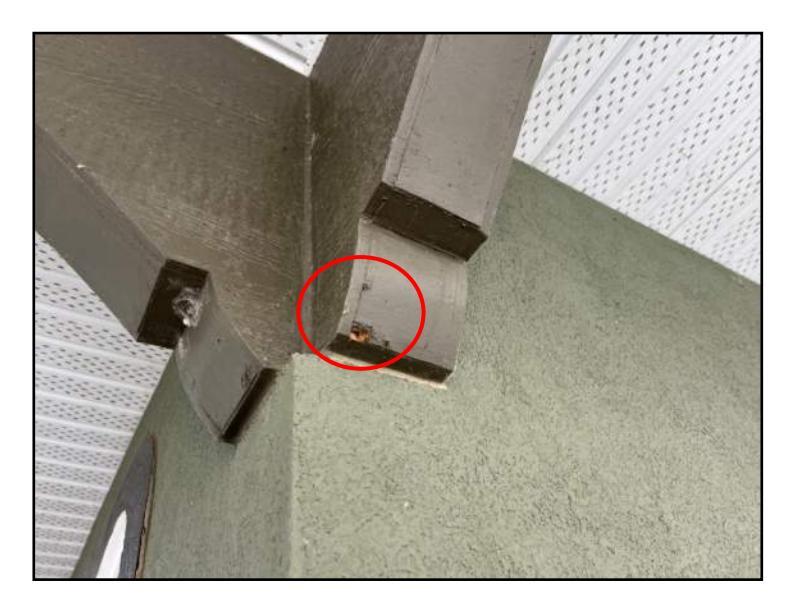
Local damage was noted at one corbel (see photo below).

Photo 2.1.2.2-1 Damage at wood corbel

The corbels and shelving are located such that they are protected by large roof overhangs, and we expect these elements will have a long service life. We recommend you budget to repair and repaint the corbels as needed. A budget for painting has been included with the exterior cladding in Section 2.2.1.1. Local repairs are expected to be completed as part of regular maintenance.

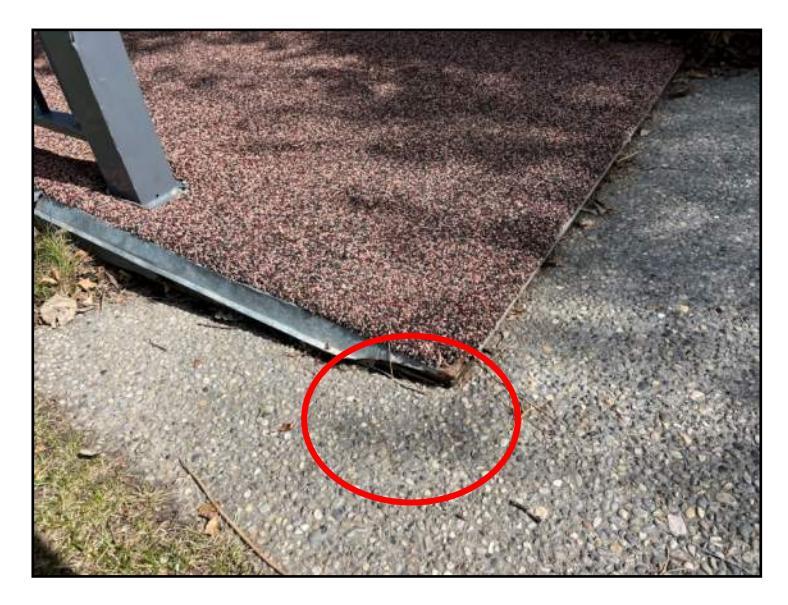
Photo 2.1.2.3-2 Damaged flashing with surface corrosion, exposing the wood structure at the base of the ramp

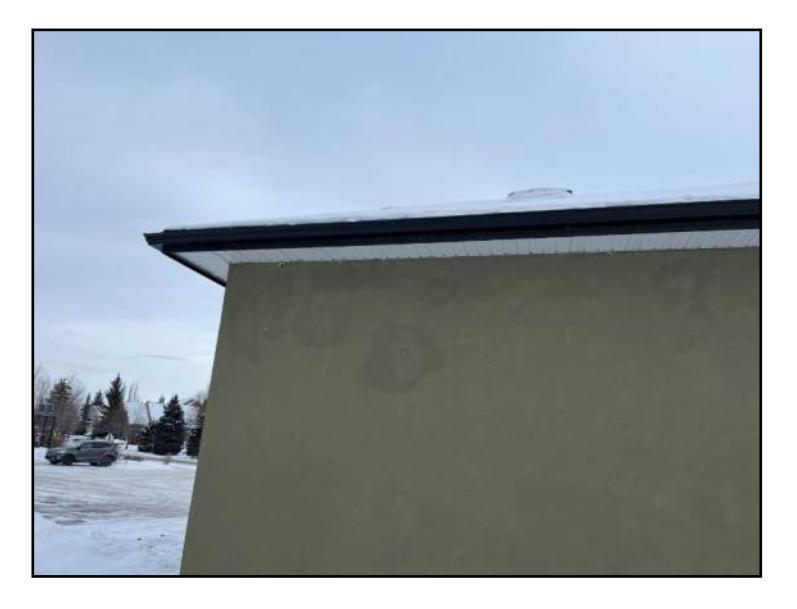
Photo 2.2.1.1-2 Repairs at EIFS at south wall of garage

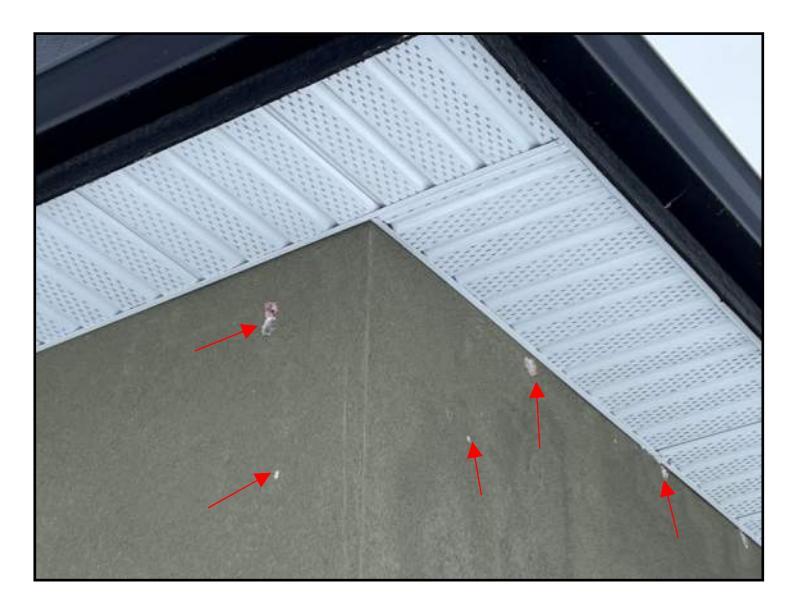
Photo 2.2.1.1-3 Impact damage at garage EIFS

We recommend you plan to replace the EIFS cladding at the end of the component's useful life. As replacement is anticipated to be beyond the report term, and budgets have not been included in Table 1.

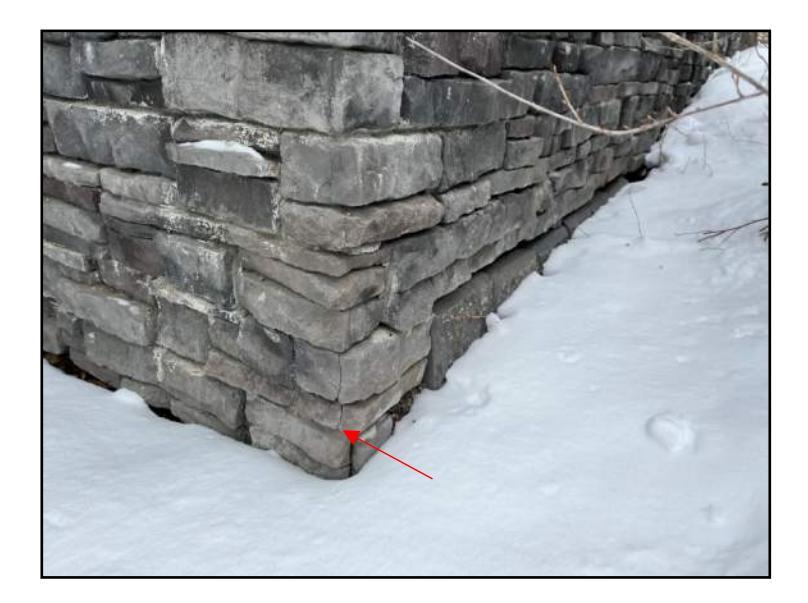
Photo 2.2.1.3-1 Cracked veneer at corner of ramp at Lake House

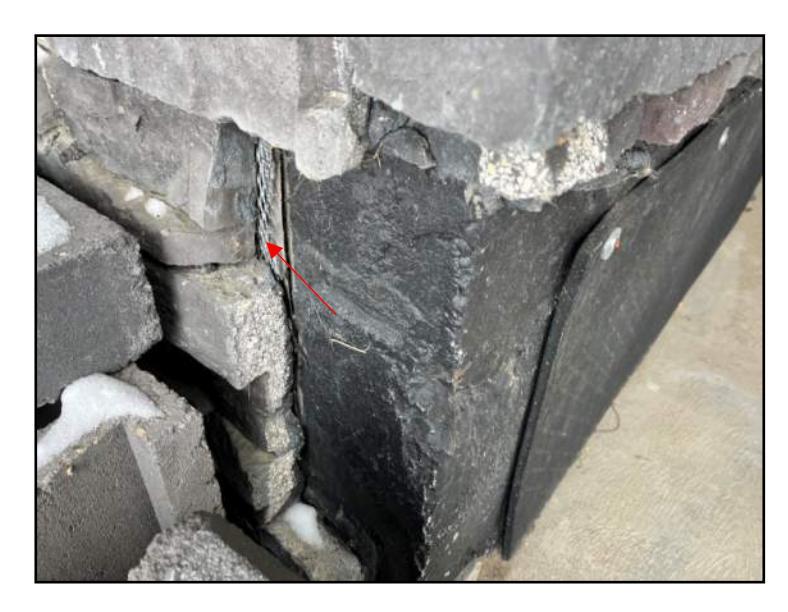
Photo 2.2.1.3-2 Missing veneer with exposed wire mesh at north wall of Lake House

We recommend you plan to replace the manufactured stone cladding at the end of the component's useful life. As replacement is anticipated to be beyond the report term, a budget has not been included in Table 1.

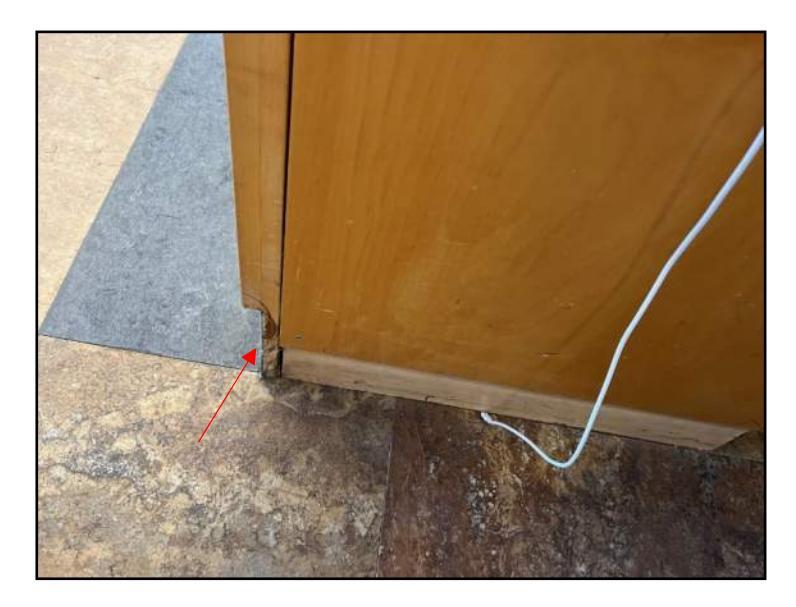
Photo 2.3.2.1-2 Local damage at service desk

We recommend you plan to replace the built-in furnishings at the end of the component's service life. Most of the casework and counters have exceeded a typical service life; however, we anticipate the service lives can be extended as the condition remains fair. Budgets have been included in Table 1 accordingly.

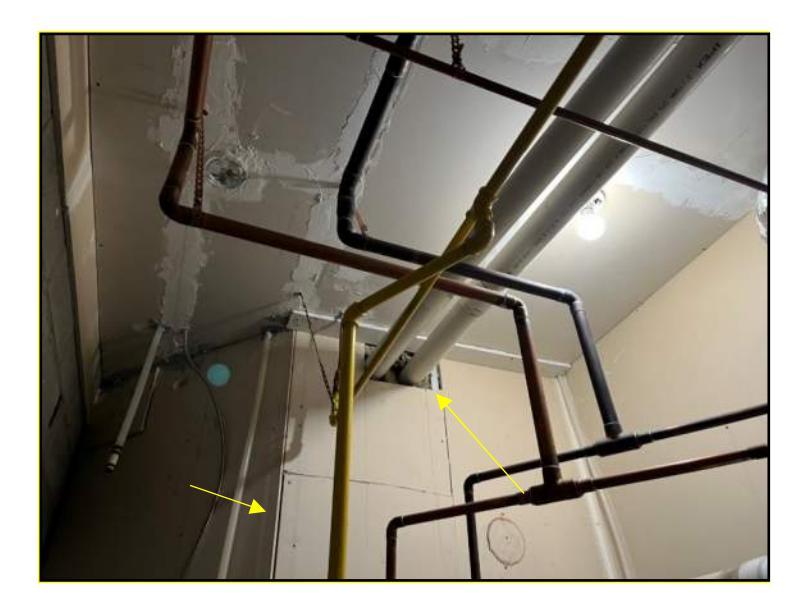
Photo 2.6.4.1-1 Mechanical penetration without firestopping, and gypsum board joints without tape or mud

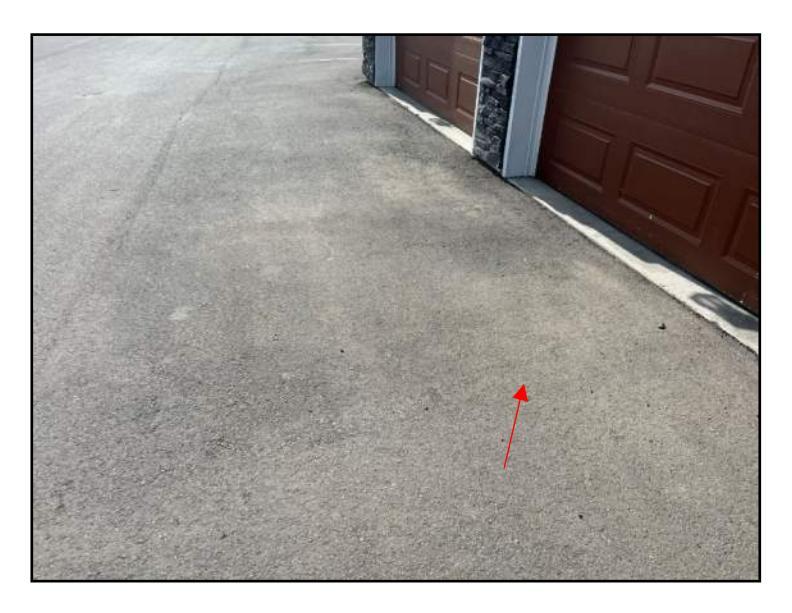
Photo 2.7.1.1-2 Settlement / heaving at north side of garage

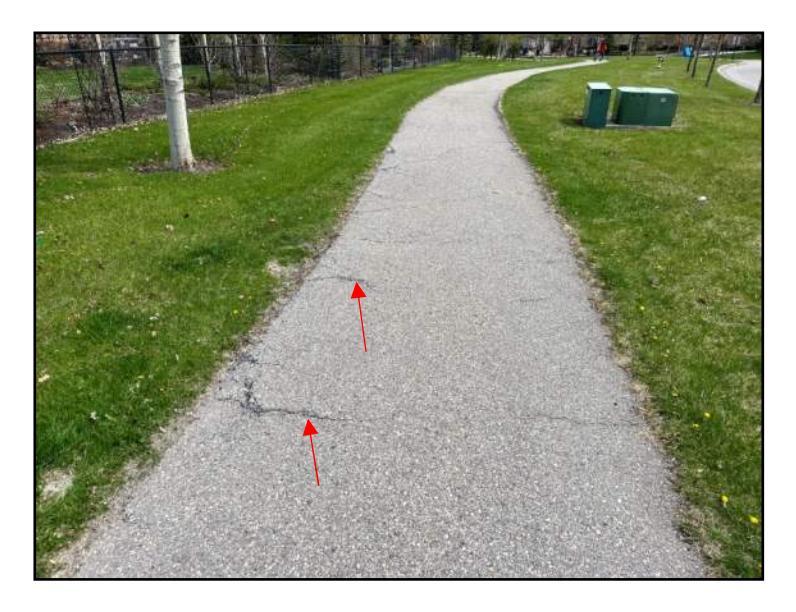
Photo 2.7.1.2-1 Raised asphalt sidewalk areas that may be tripping hazards

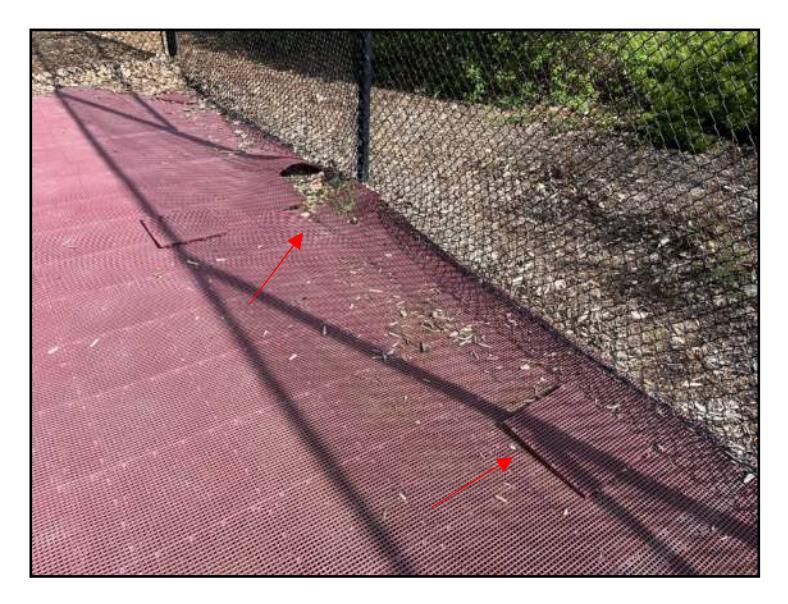
Photo 2.7.1.3-1 Lifting and displaced sports surface tiles

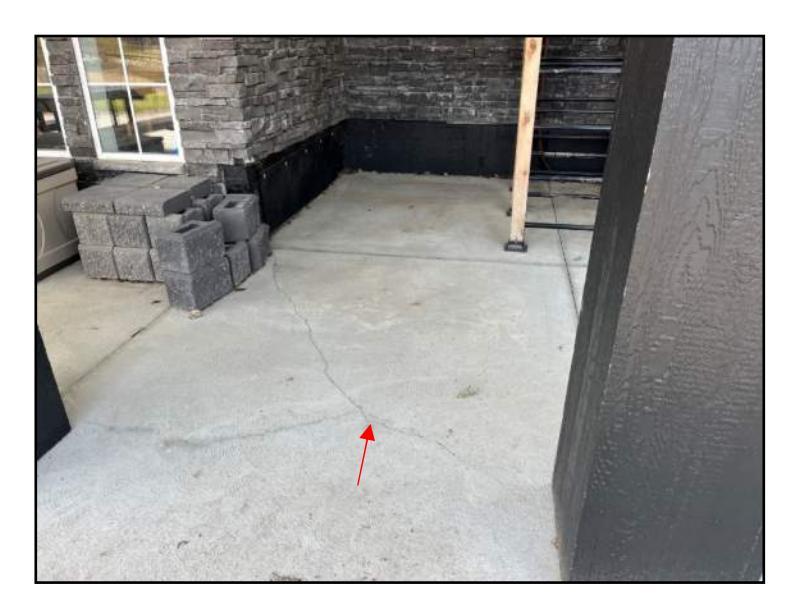
Photo 2.7.1.4-1 Crack at concrete pad at north side of Lake House

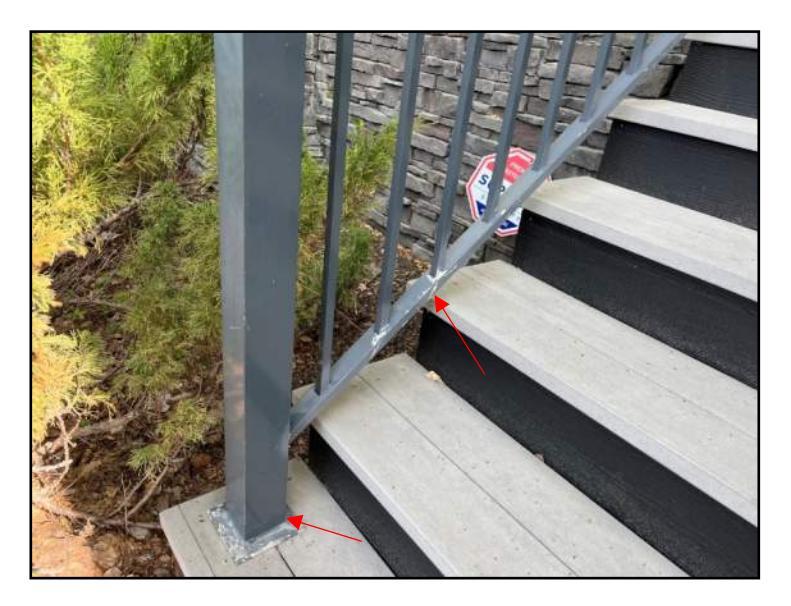
Photo 2.7.2.1-2 Peeling finish at guard rail

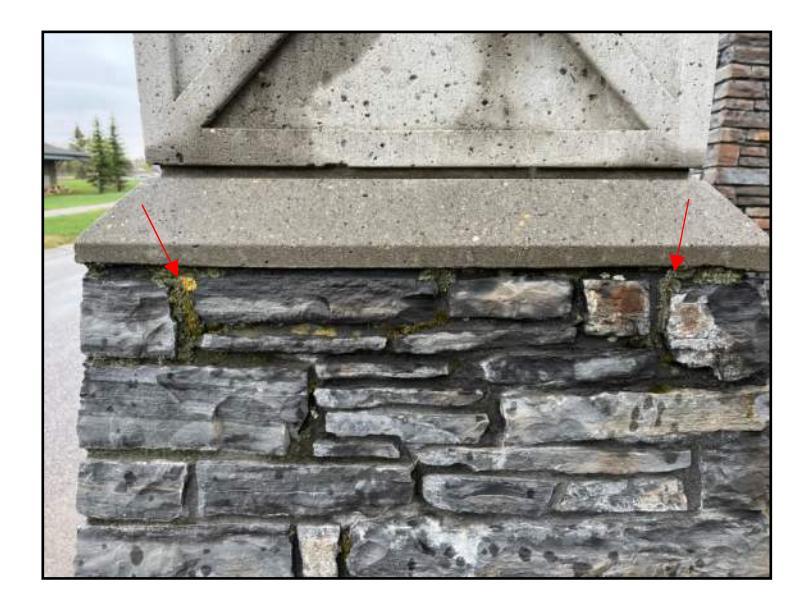
Photo 2.7.3.1-4 Vegetation growth at stone cladding

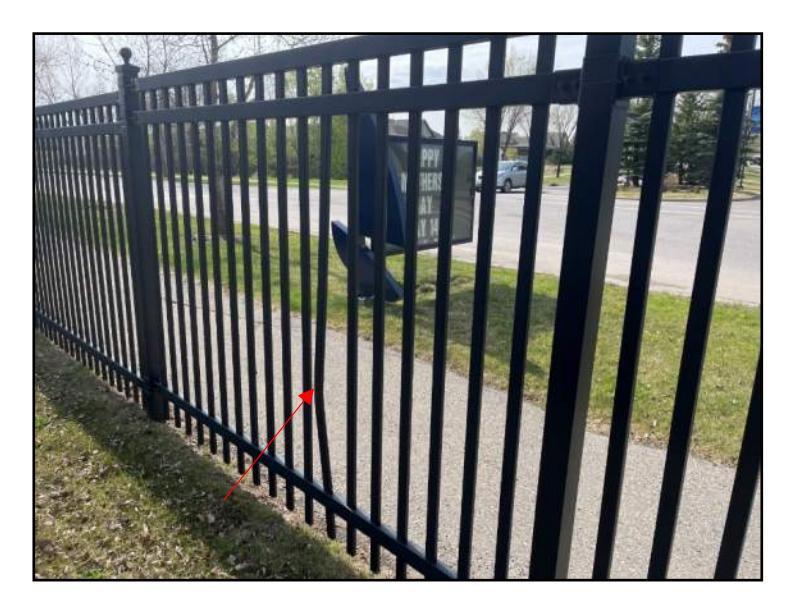
Photo 2.7.4.2-2 Bent fence picket

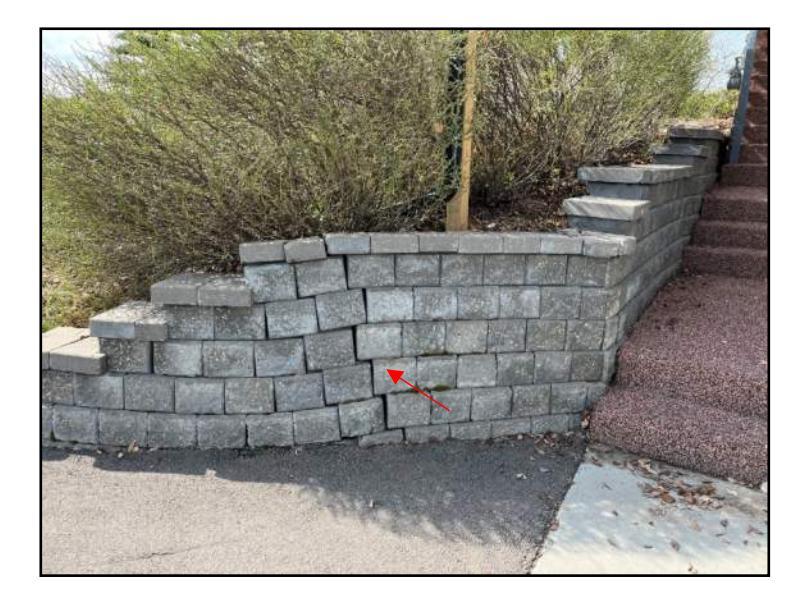
Photo 2.7.5.1-1 Evidence of movement at retaining wall

2.7.5.1	Repair the retaining walls	2025	\$5,000
2.7.8.4a	Replace the gas fire pit burner	2025	\$3,000
2.7.9.3a	Replace some aeration diffusers (20) for lake	2025	\$5,000

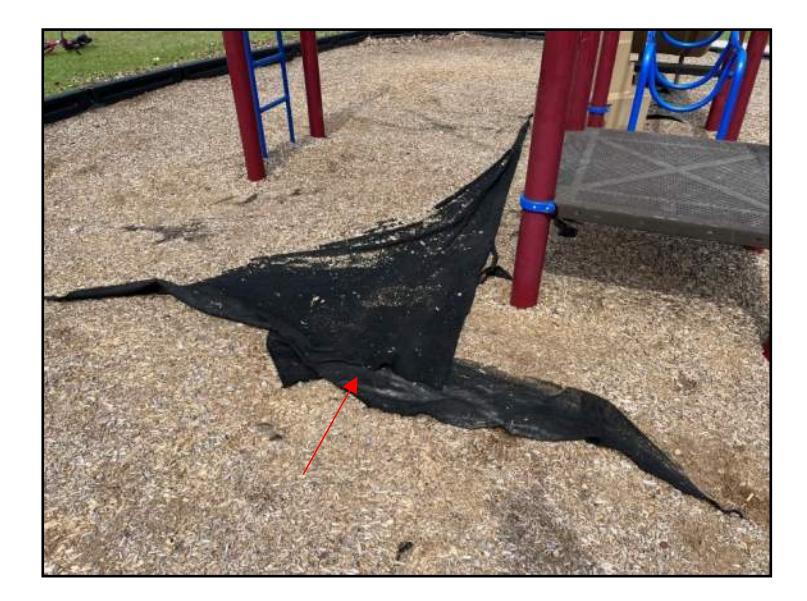
Photo 2.7.8.2-2 Loose landscaping fabric
