Lifecycle Assessment Report

The Lake at Heritage Pointe Owners Association

Heritage Pointe, Alberta

Report No. 2300676.00

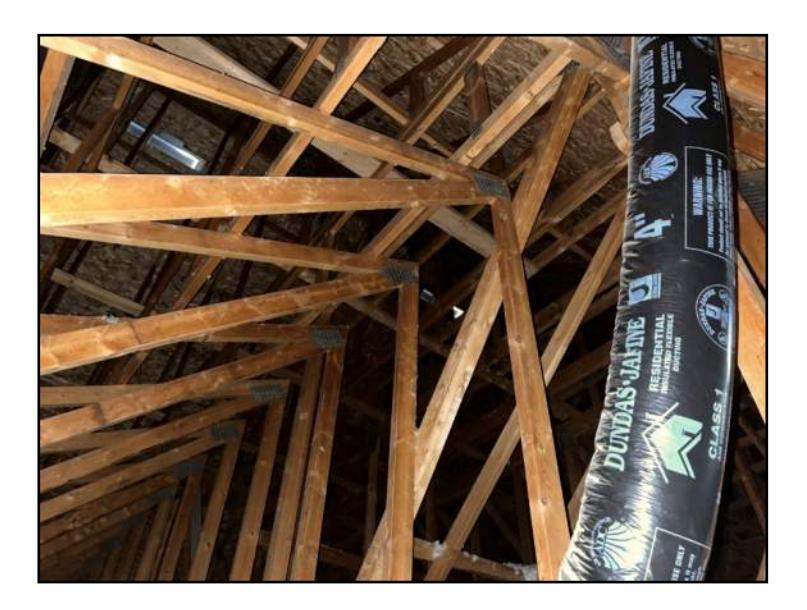
Excessive deflection, cracking or other evidence of structural distress was not observed or reported. There was no evidence or reports of long-term leakage that would lead us to expect concealed structural damage.

Photo 2.1.2.1-1 Attic at Lake House

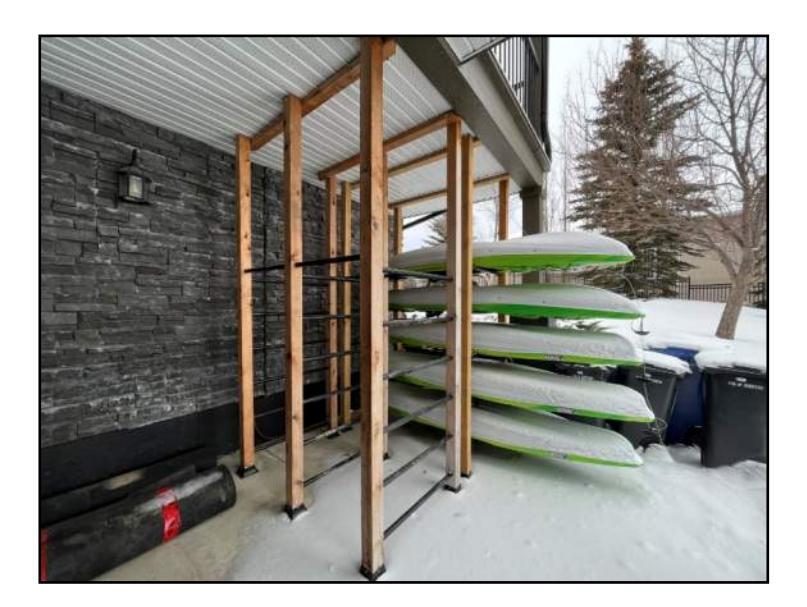
Photo 2.1.2.2-2 Wood shelving

The corbels and shelving are located such that they are protected by large roof overhangs, and we expect these elements will have a long service life. We recommend you budget to repair and repaint the corbels as needed. A budget for painting has been included with the exterior cladding in Section 2.2.1.1. Local repairs are expected to be completed as part of regular maintenance.

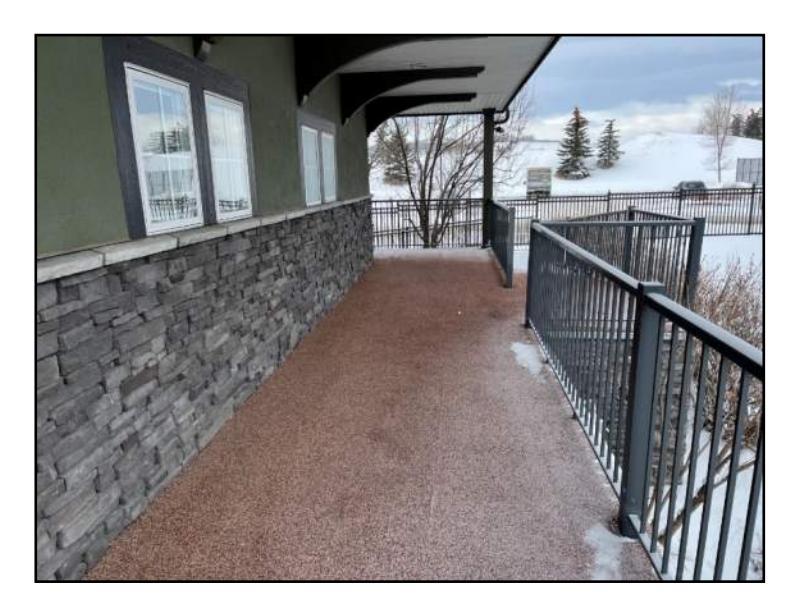
Photo 2.1.2.3-1 Raised deck

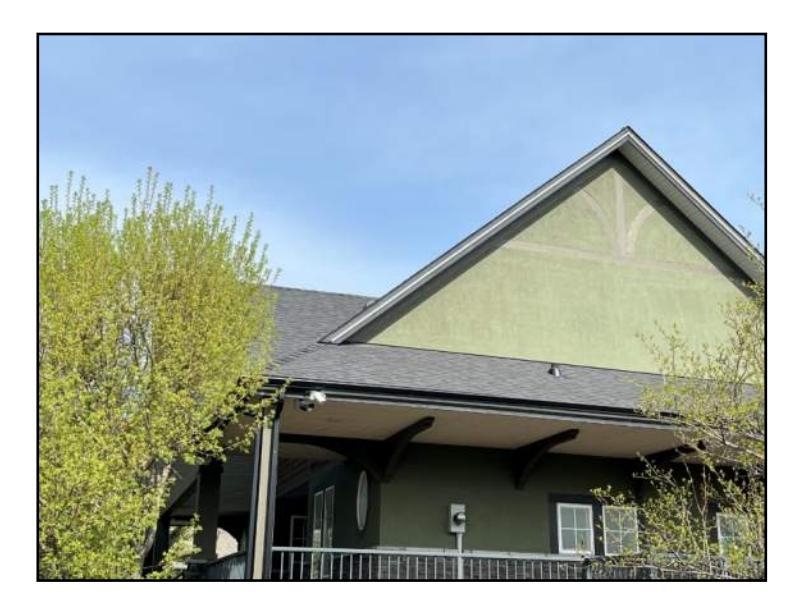
Photo 2.2.1.1-1 Painted EIFS at Lake House

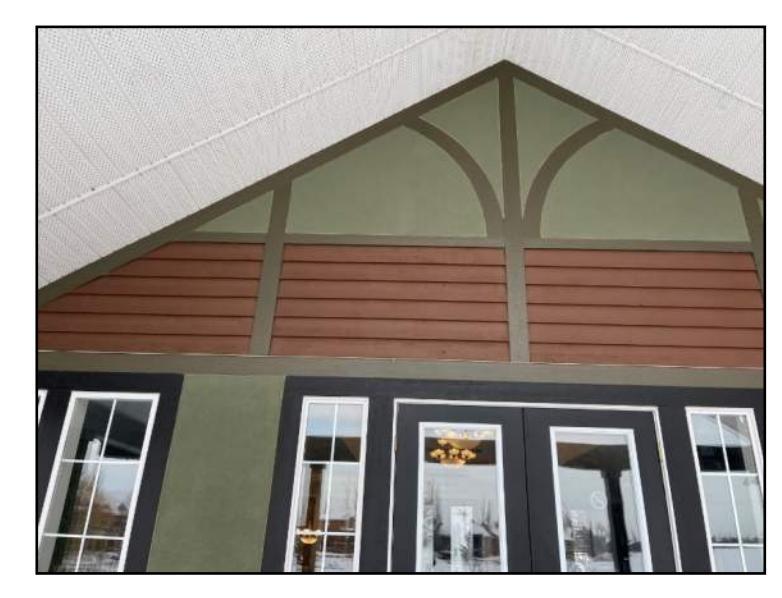
Photo 2.2.1.2-1 Wood cladding and trim at the Lake House

We recommend you plan to replace the wood siding and trim at the end of the component's service life. Replacement budgets have been included in Table 1. We have aligned the replacement at the Lake House with the window replacement project.

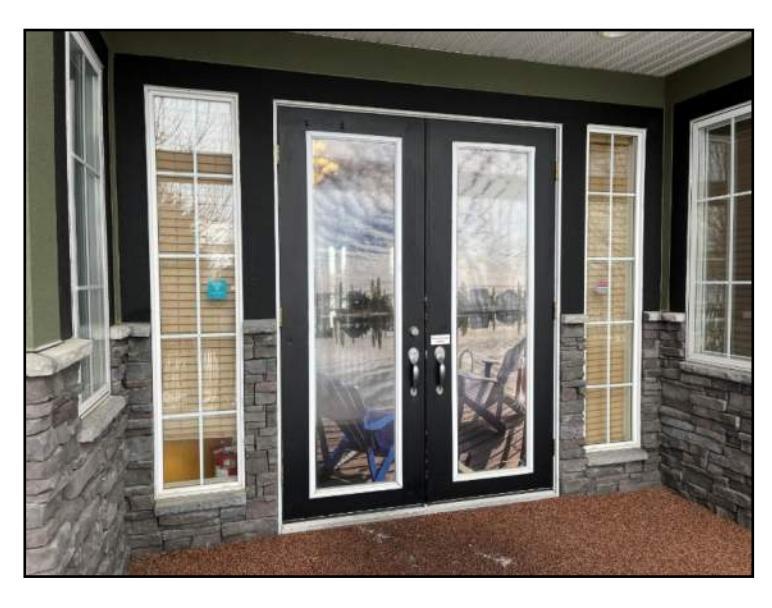
Photo 2.2.2.2-1 Lower main change room exterior doors

We recommend you plan to replace the entrance doors at the end of the component's useful life. A replacement budget has been included in Table 1.

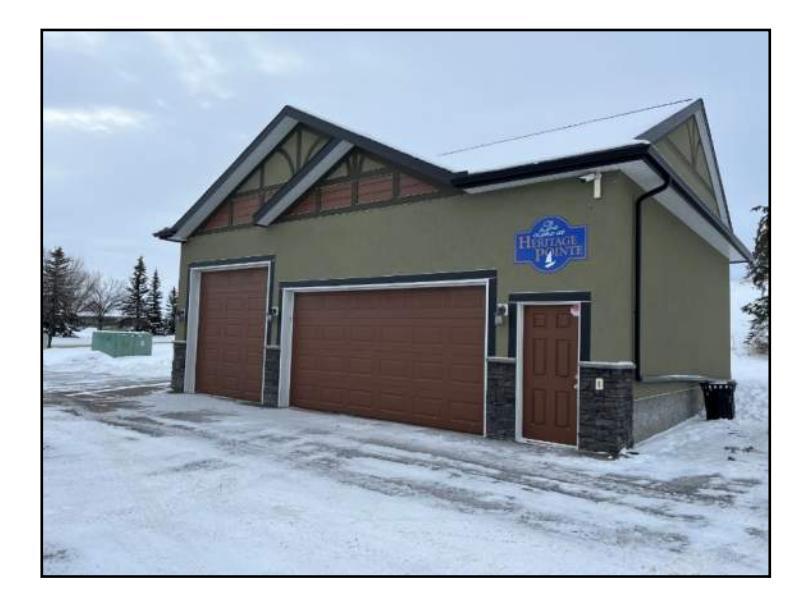
Issues with operations were not reported nor observed.

Photo 2.2.2.4-1 Insulated metal overhead doors at garage

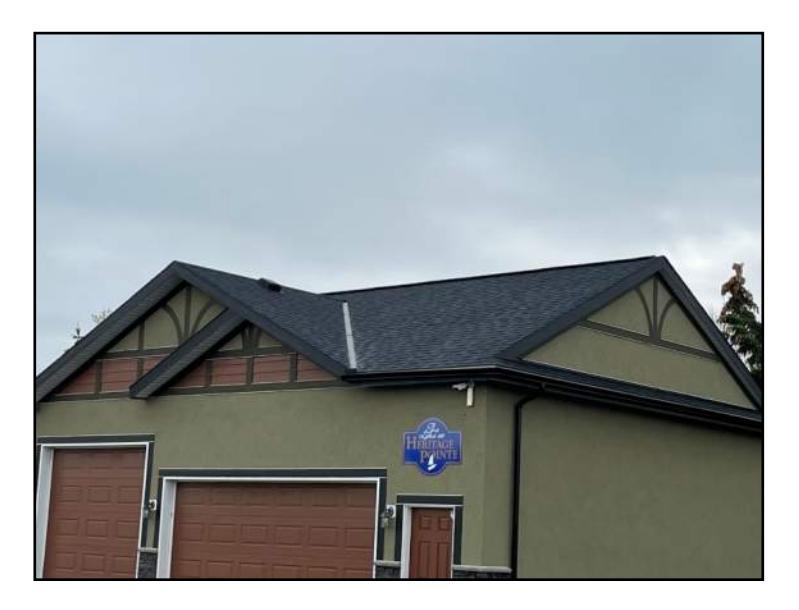
At sample attic areas accessed, we noted no apparent accumulation build-up of moisture, water ingress, or deterioration of the roof framing members.

Photo 2.2.3.1-1 Shingled roof at garage

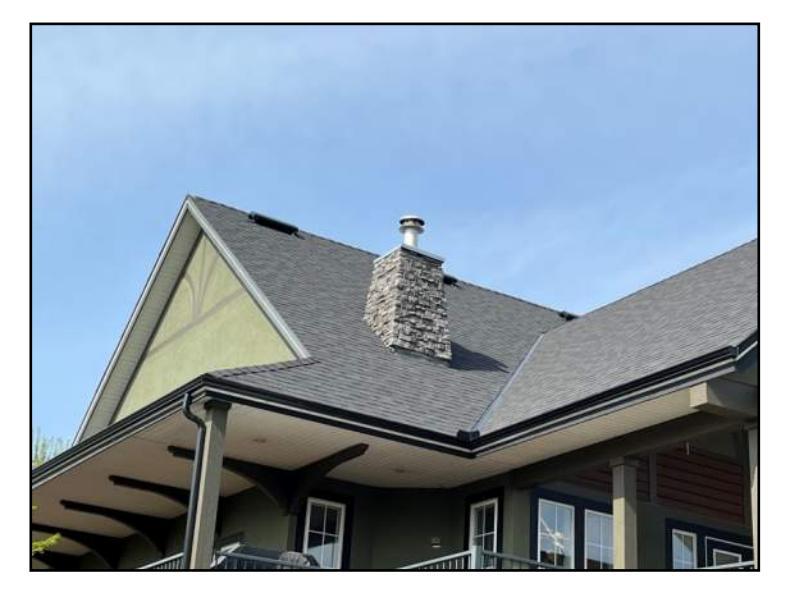
Photo 2.2.3.1-2 Shingled roof at Lake House

We recommend you plan to replace the shingles at the end of the component's useful life, including all associated work such as local sheathing replacement, flashing replacement, and joint sealing. Replacement budgets have been included in Table 1.

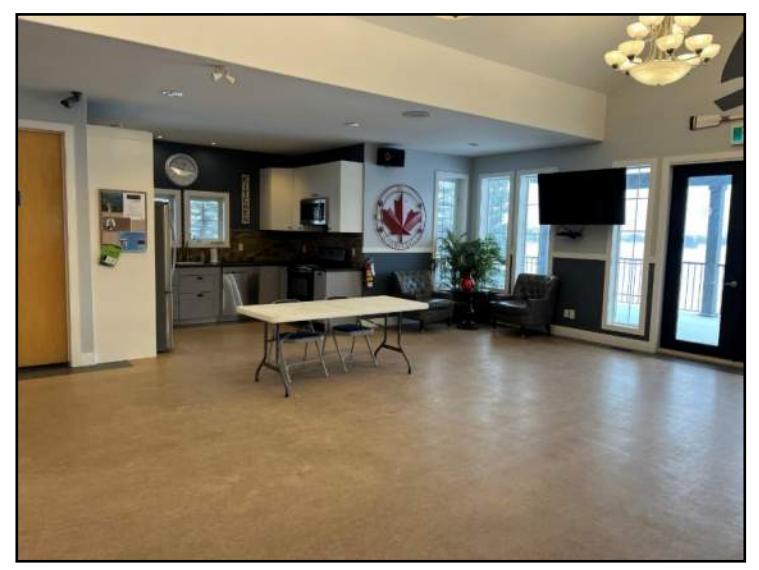
Signs of wear were noted throughout the resilient flooring.

Photo 2.3.1.3-1 Typical resilient flooring

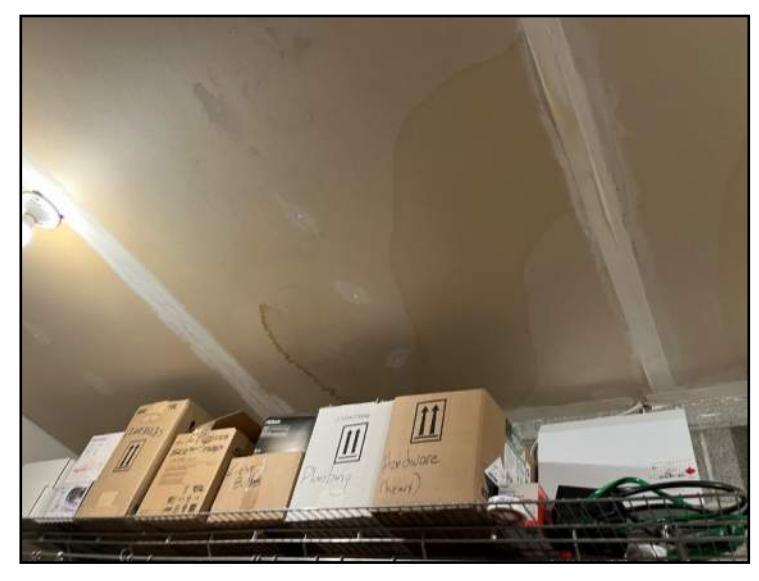
We noted stained ceilings at the mechanical room. Staff reported the staining is not from active water leakage and is likely the result of historic water damage from the plumbing located above the room.

Photo 2.3.1.4-1 Historic water damage at the ceiling of the mechanical room at the basement

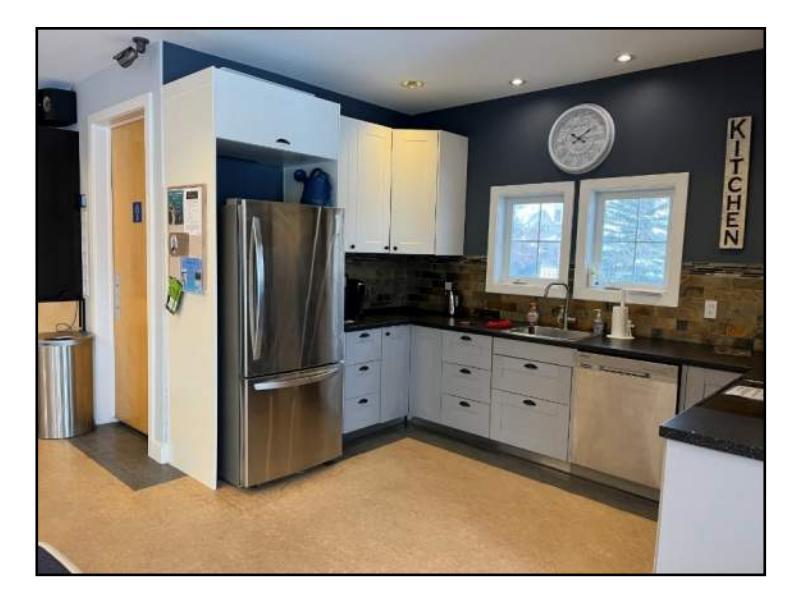
Photo 2.3.2.1-1 Built-in cabinets at kitchen

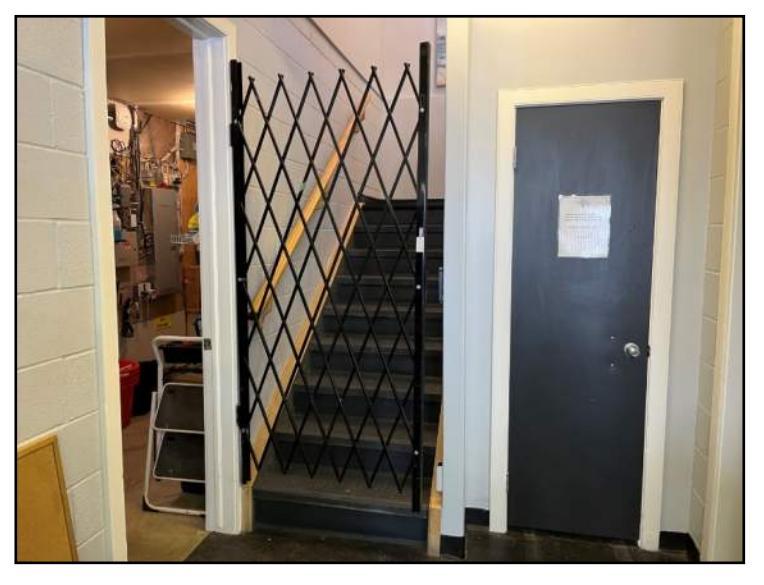
The handrail had been cut back to install the partition. The date of installation is unknown.

Photo 2.3.4.1-1 Metal security partition at base of stairs

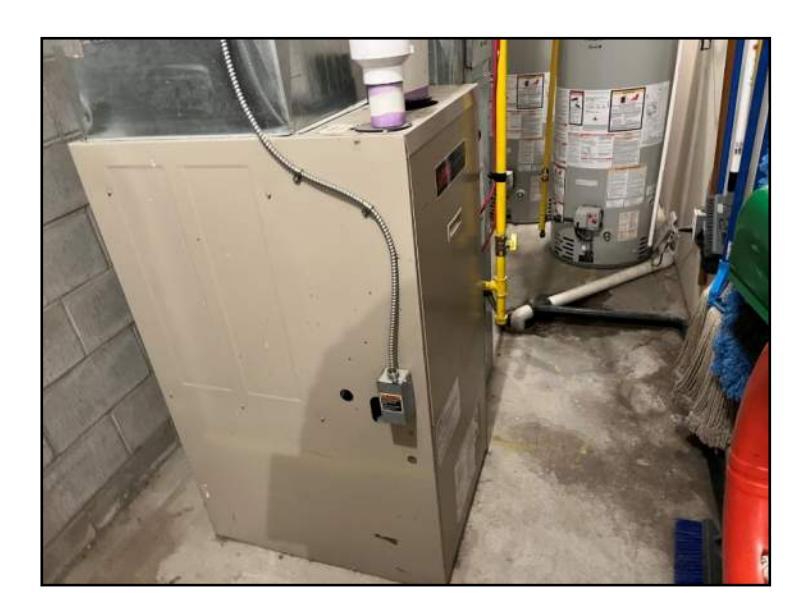
No issues were noted or reported.

Photo 2.4.2.1-1 Furnace serving the Lake House

2.3.1.1	Replace rubber tiles at the Lake House	2026	\$13,000
2.3.1.3	Replace resilient floor on main floor in the Lake House	2026	\$13,000
2.4.2.1	Replace furnace serving the Lake House	2026	\$12,000

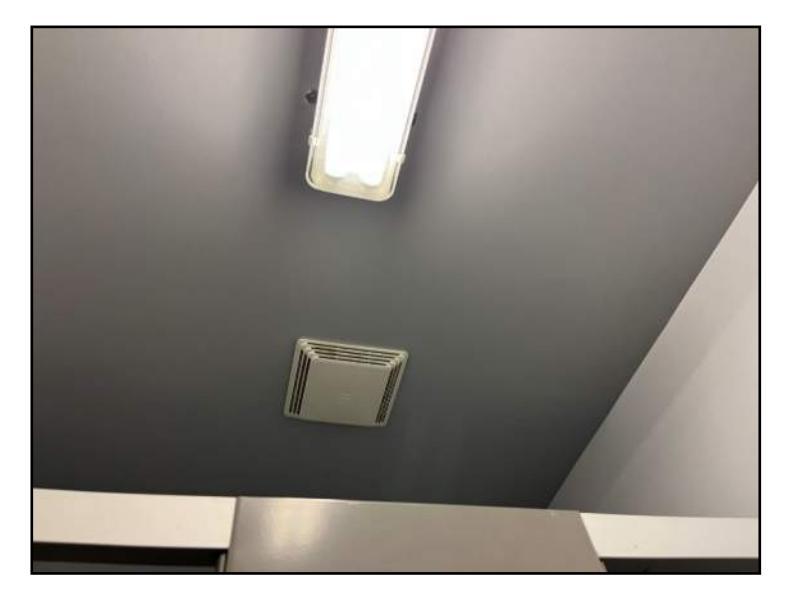
Photo 2.4.4.1-1 Typical washroom exhaust fan

We anticipate the washroom exhaust fans will be replaced individually as needed, each at a cost below the capital expense threshold.

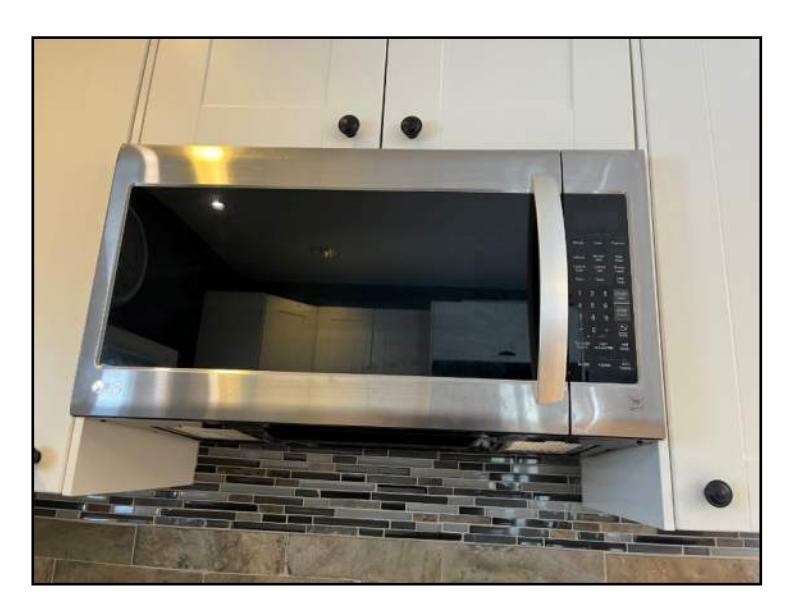
Photo 2.4.4.1-2 Microwave with hood fan

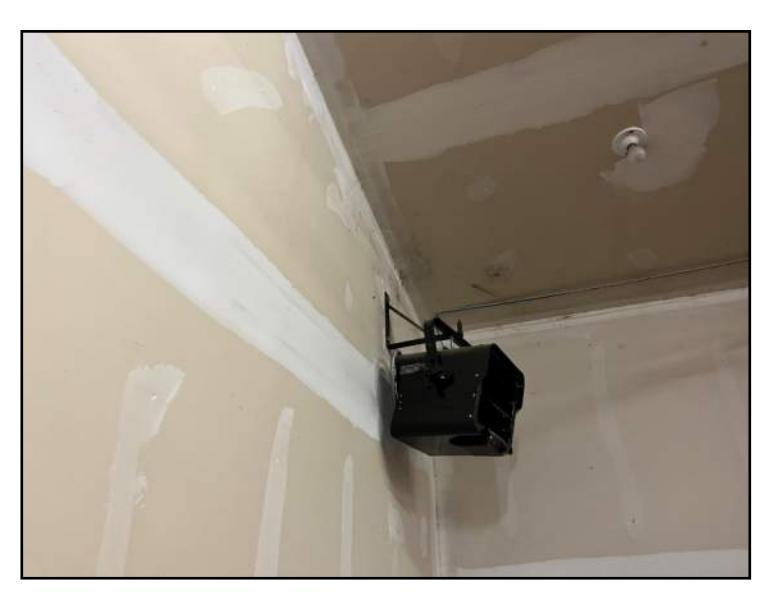
Photo 2.4.5.1-1 Ceiling-mounted electric heater at garage

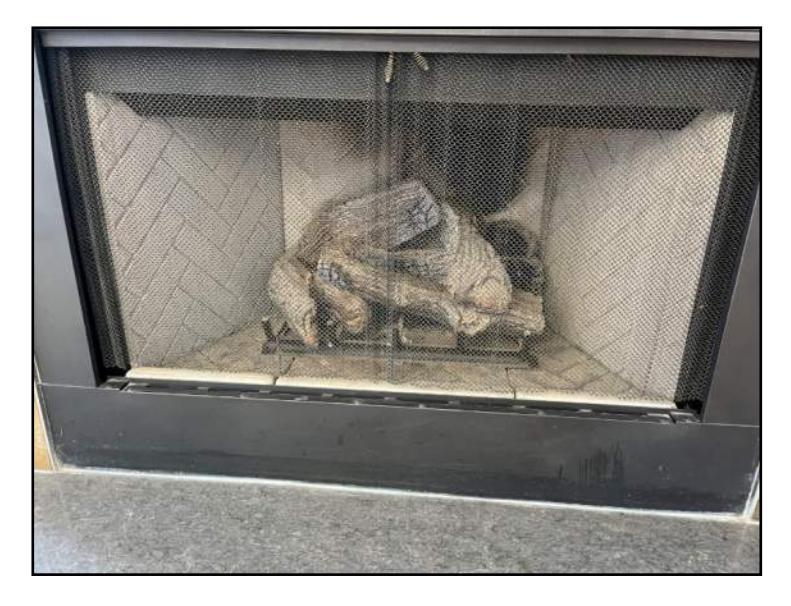
At the time of our site visit, the fireplace was not operating. Site staff reports they are in the process of repairing the fireplace as part of regular maintenance, and the issue is likely related to a switch.

Photo 2.4.5.2-1 Natural gas fireplace at Lake House upper level

2.4.5.2	Replace natural gas fireplace at Lake House	2026	\$10,000
2.5.2.2b	Replace transformer at end of service life	2026	\$6,000
2.7.1.5	Reset concrete unit pavers	2026	\$15,000

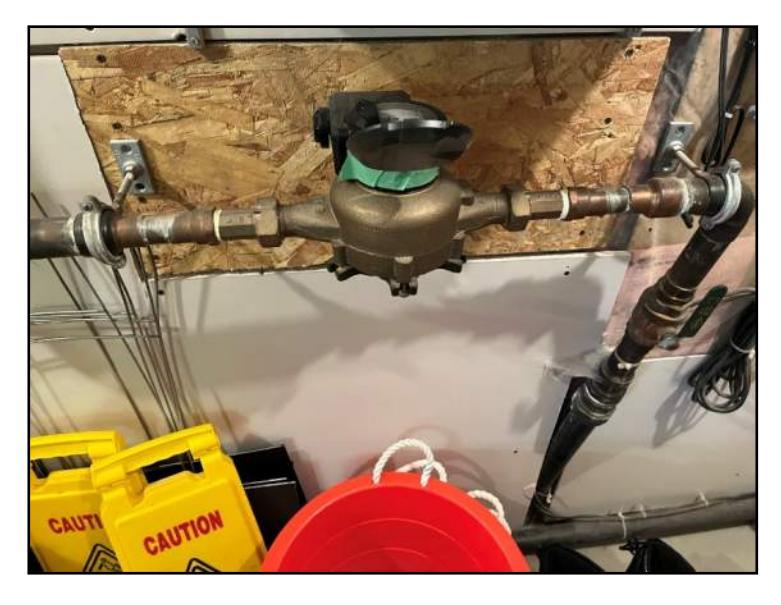
There are water meters at each house and at the basement mechanical room of the Lake House. No backflow preventer is present at the Lake House.

Photo 2.4.6.1-1 Incoming water line and meter at Lake House

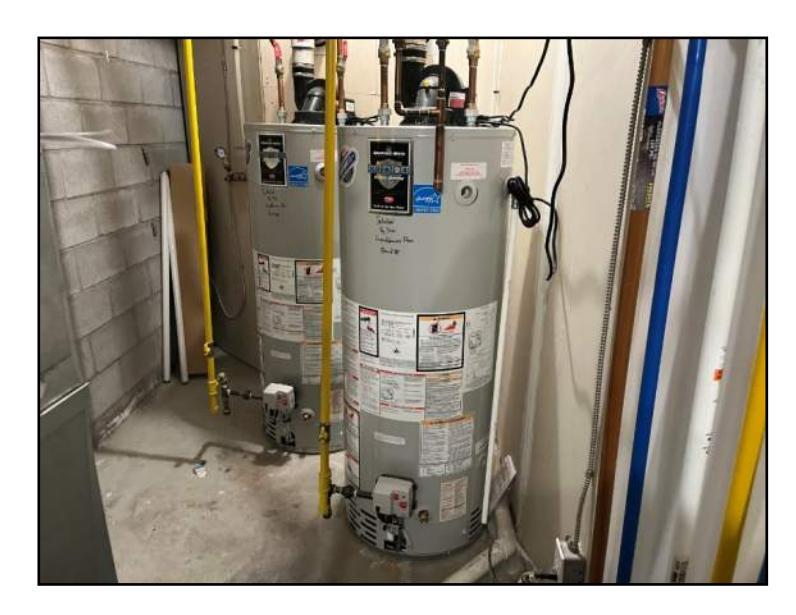
Photo 2.4.6.3-1 Domestic hot water tank heaters for Lake House

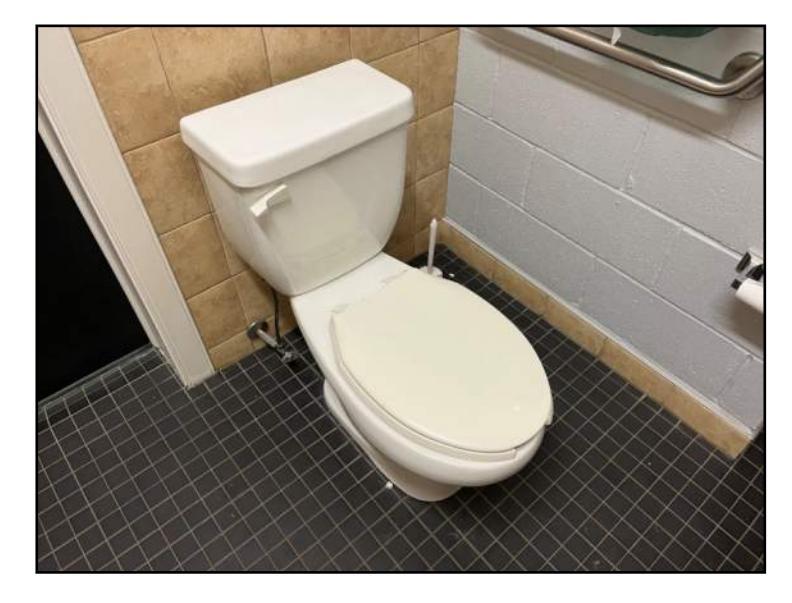
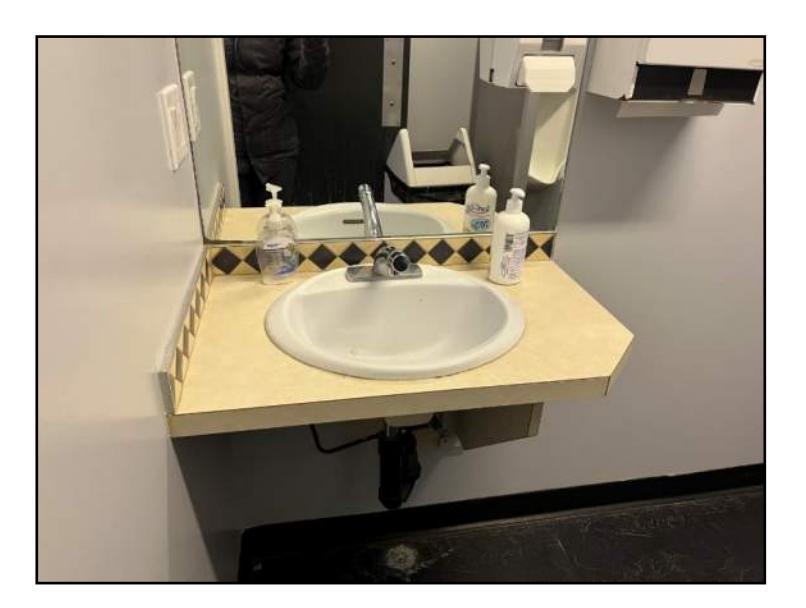
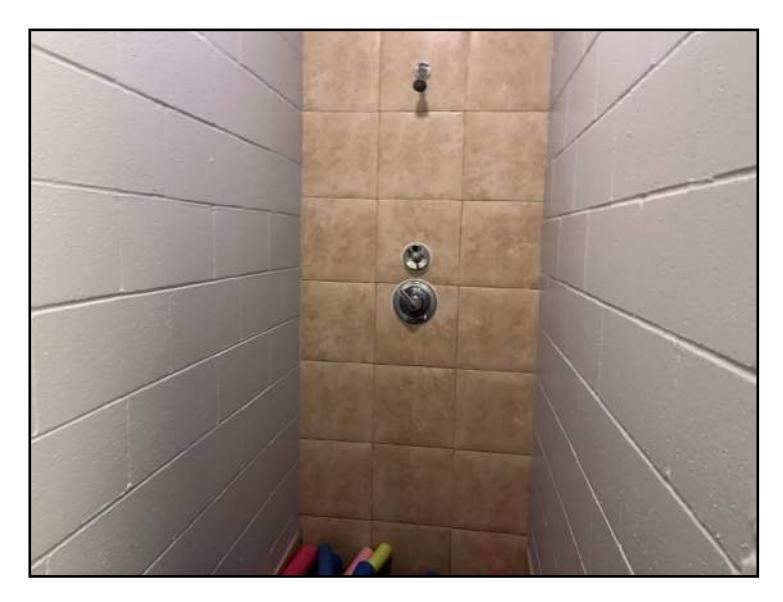
Photo 2.4.6.4-1 Typical water closet

Photo 2.4.6.4-2 Typical lavatory

Photo 2.4.6.4-3 Typical shower fixtures

Most of the plumbing fixtures have exceeded a typical service life; however, we expect the service life can continue to be extended based on conditions. A replacement budget has been included in Table 1.

2.4.6.4	Replace washroom plumbing fixtures	2028	\$33,000
2.5.3.1a	Replace interior light fixtures at Lake House	2028	\$11,000
2.5.3.3	Replace exterior soffit and wall-mounted light fixtures at Lake House	2028	\$13,000

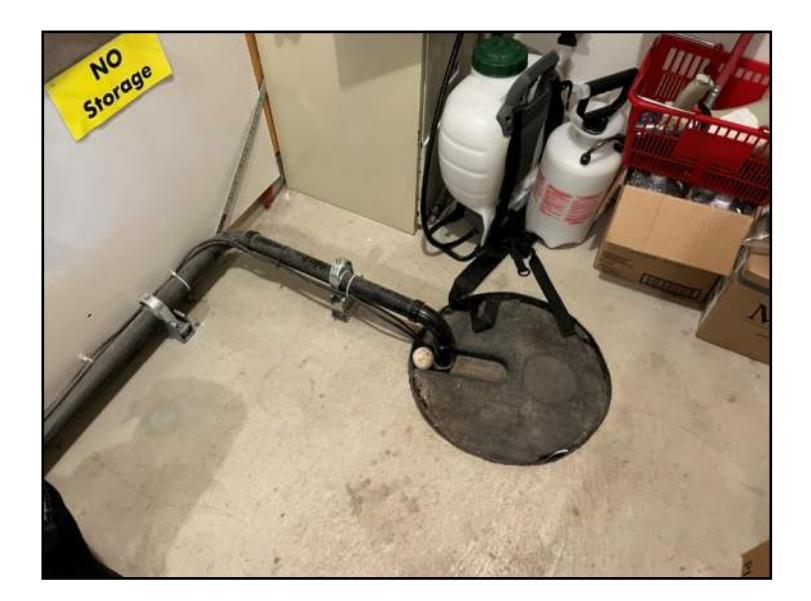
Photo 2.4.7.3-1 Stormwater sump pit

Sump pits are expected to remain in service for the life of the building.

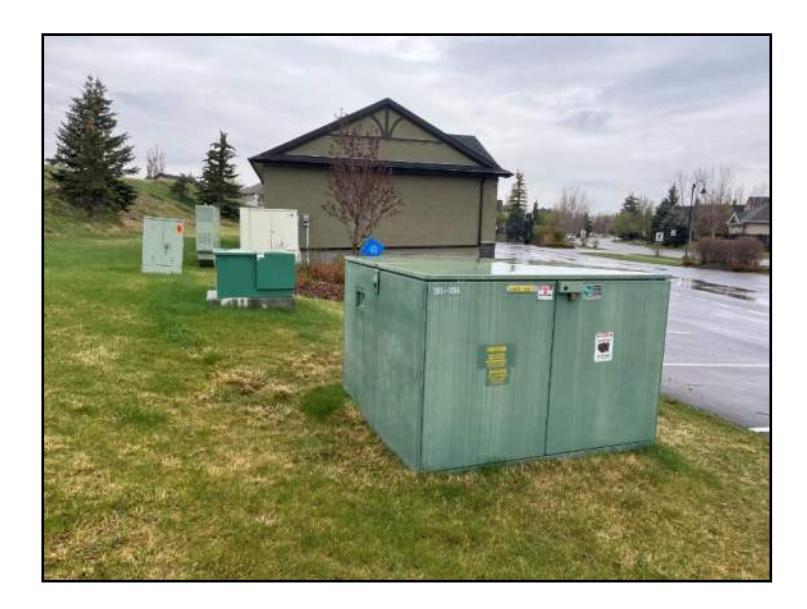
Photo 2.5.1.1-1 Typical utility pad-mounted transformer

Capital expenditures are not included as the transformer, buried lines, and meters are assumed to be owned by the utility supplier.

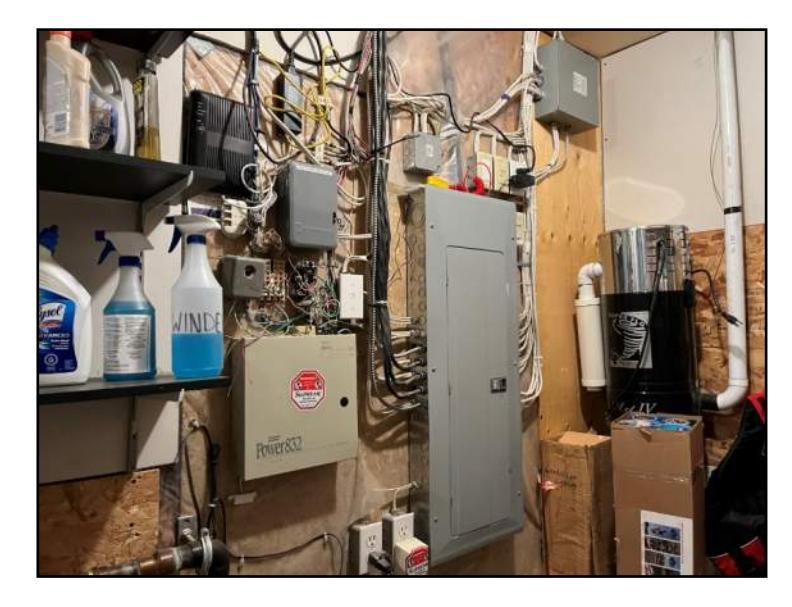
Photo 2.5.2.1-1 Electrical branch circuit panel for Lake House

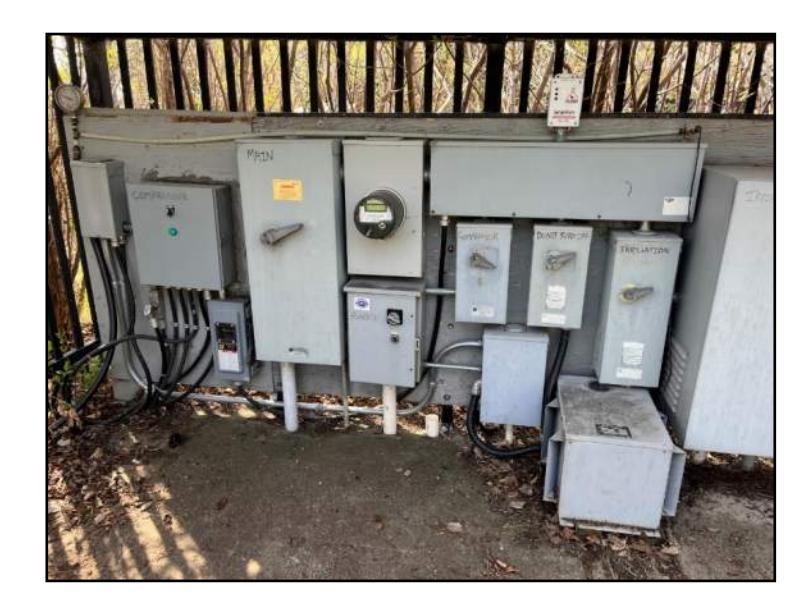
Photo 2.5.2.2-1 Electrical distribution equipment for lake equipment

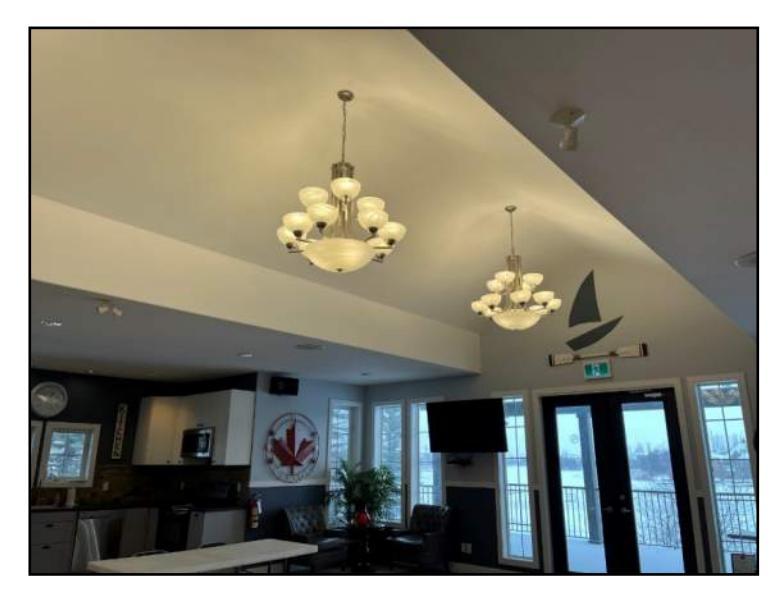
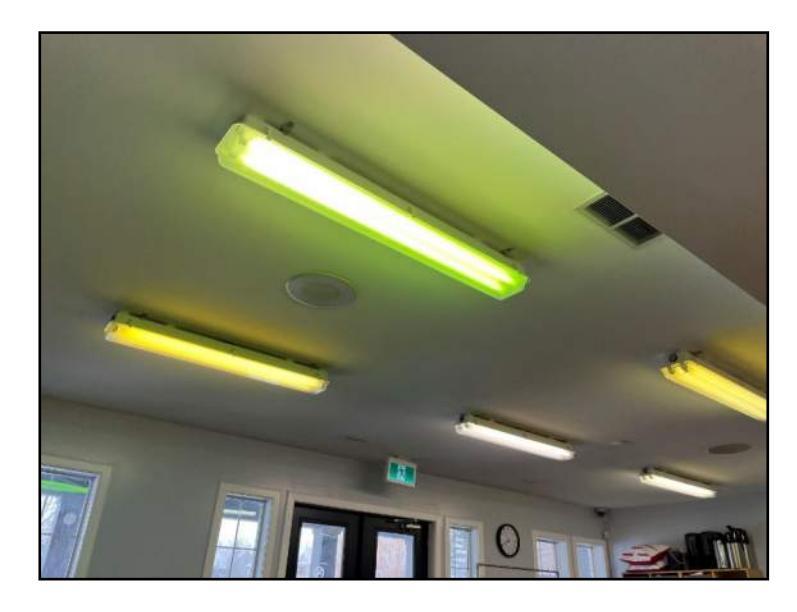
Photo 2.5.3.1-1 Chandelier and recessed downlight (potlight) fixtures at upper level

Photo 2.5.3.1-2 Typical linear fluorescent fixtures at lower level

We recommend you plan to replace the light fixtures at the end of the component's useful life. Most of the light fixtures have exceeded a typical service life; however, we anticipate the service life can continue to be extended based on conditions. Replacement budgets have been included in Table 1 accordingly. We have assumed replacement with LED fixtures, as these are current industry standard.

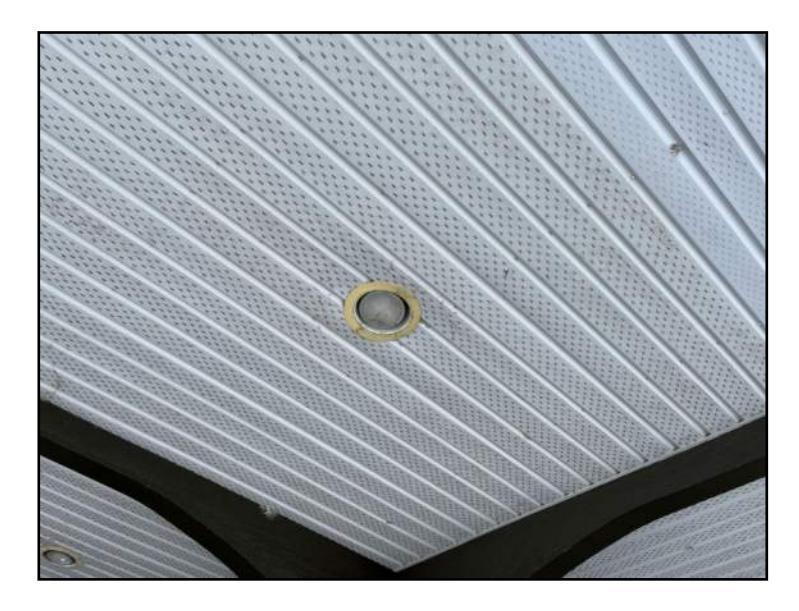
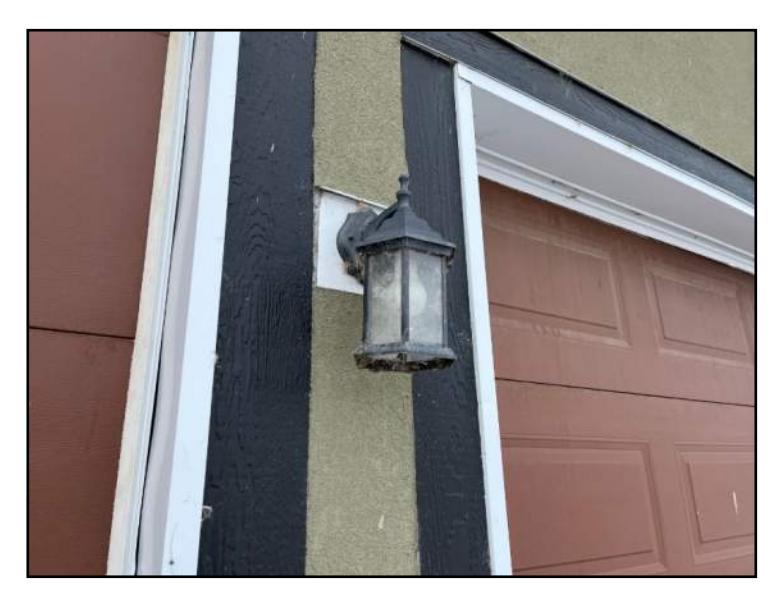
Photo 2.5.3.3-1 Typical soffit recessed downlight (potlight) fixture at Lake House

Photo 2.5.3.3-2 Wall-mounted light fixture at garage

We recommend you plan to replace the light fixtures at the end of the component's service life. Light fixtures at the Lake House have exceeded a typical service life; however, based on conditions we anticipate the service life can continue to be extended. A replacement budget has been included in Table 1 accordingly.

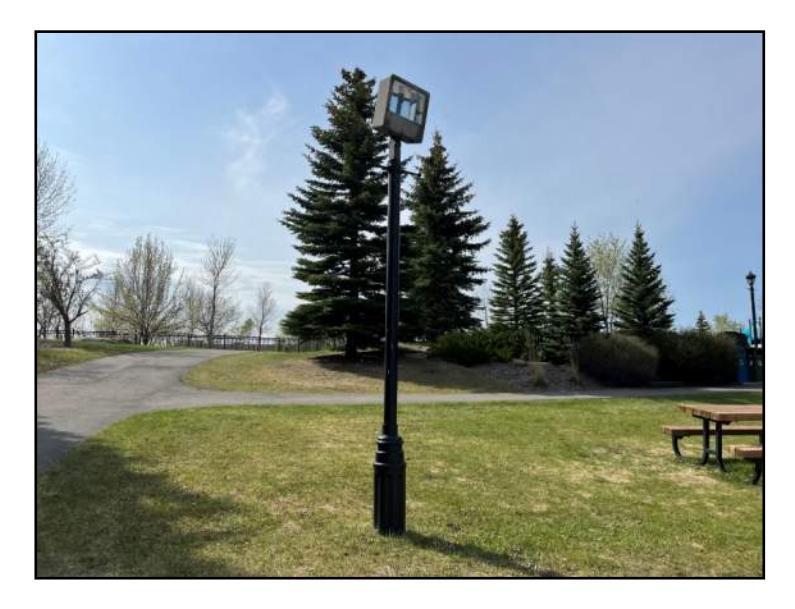
Photo 2.5.3.5-1 Pole-mounted light fixtures

The pole-mounted light fixtures (light fixtures only) have remained in service beyond a typical service life for this component; however, based on current conditions we anticipate the service life can continue to be extended. A replacement budget has been included in Table 1 after an extended service life.

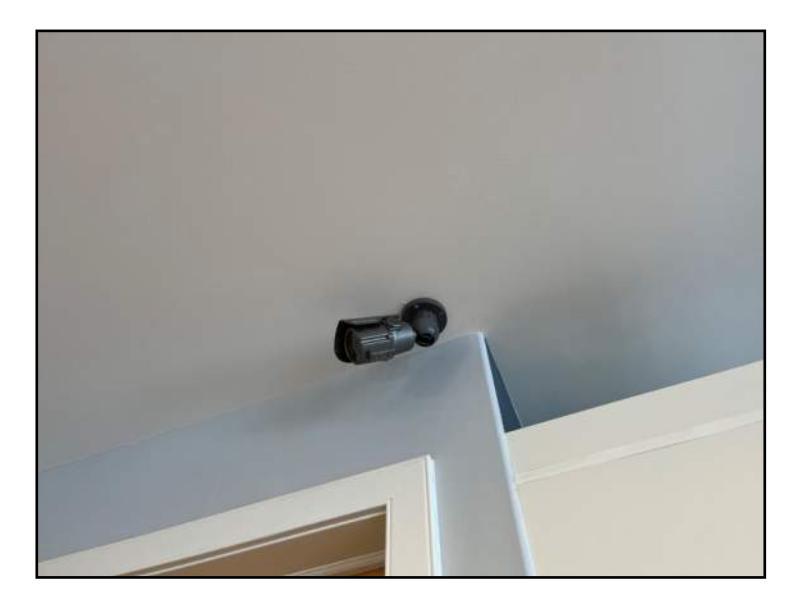
Photo 2.5.4.2-1 Indoor security camera

We recommend you plan to replace the security camera system at the end of the system's useful life. A budget has been included in Table 1. Service life has been assigned as 15 years based on changing technology.

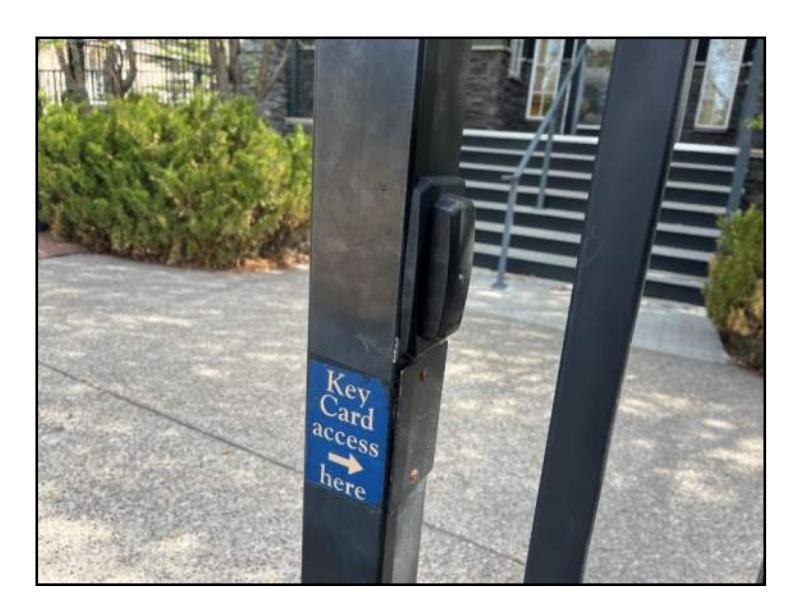
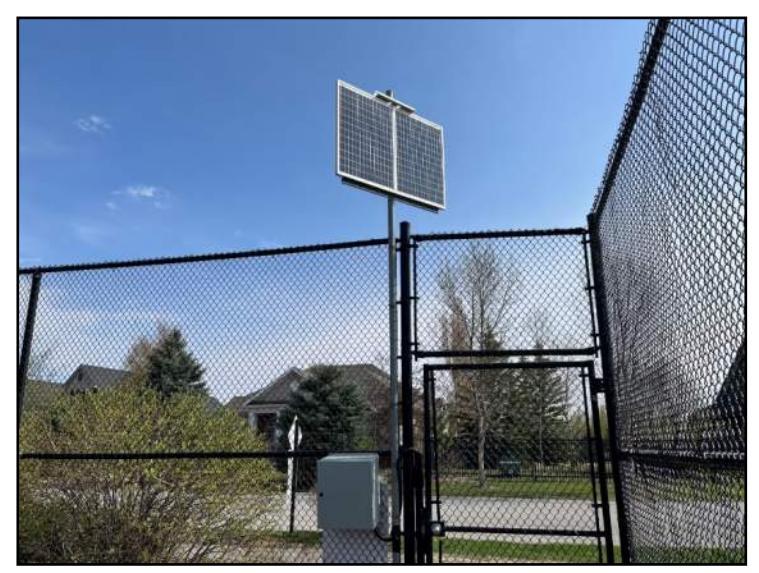
Photo 2.5.4.4-1 Access control card reader at Lake House

Photo 2.5.4.4-2 Access control card reader with solar panel at tennis court

We recommend you plan for replacement of the access control system at the end of the useful life for this component. A replacement budget has been included in Table 1. Service life has been assigned as 15 years based on changing technology.

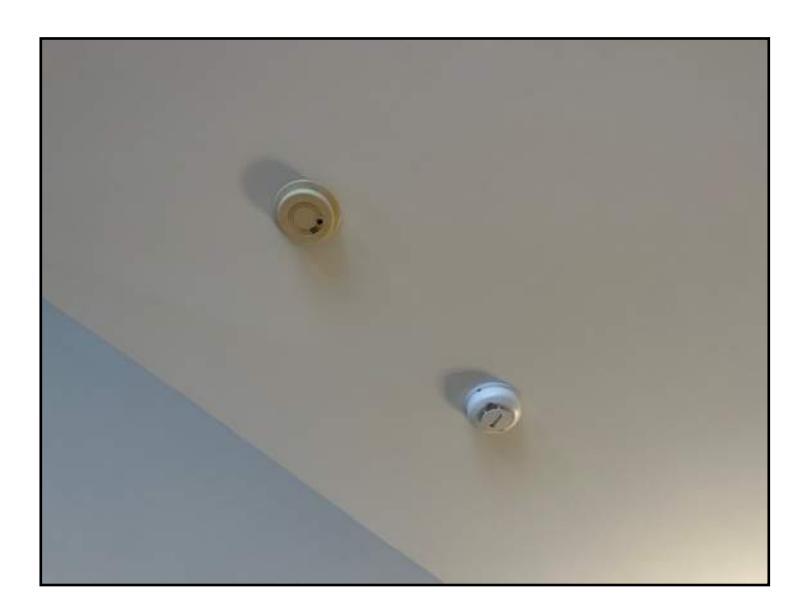
The Lake House is equipped with hard-wired smoke/heat alarms at each level for fire detection and signaling. The detectors are connected to the intrusion alarm and detection system.

Photo 2.6.2.1-1 Typical smoke/heat alarms

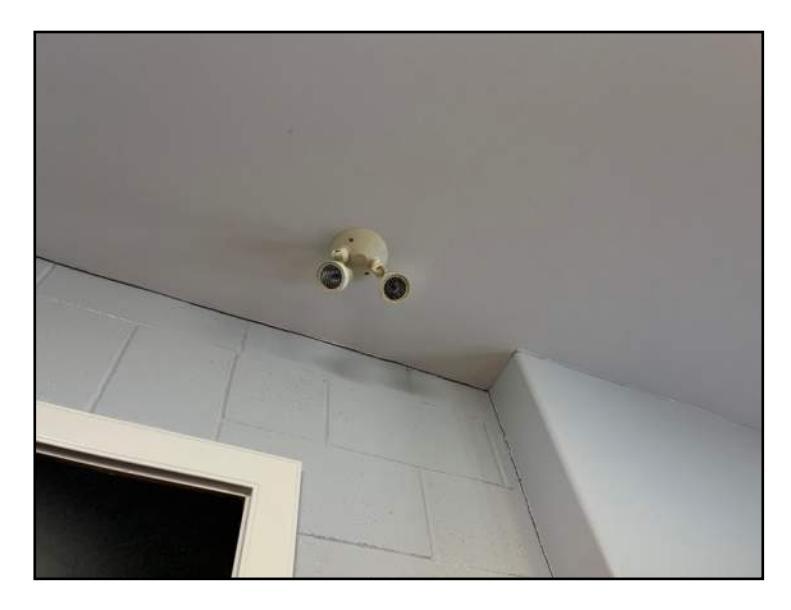
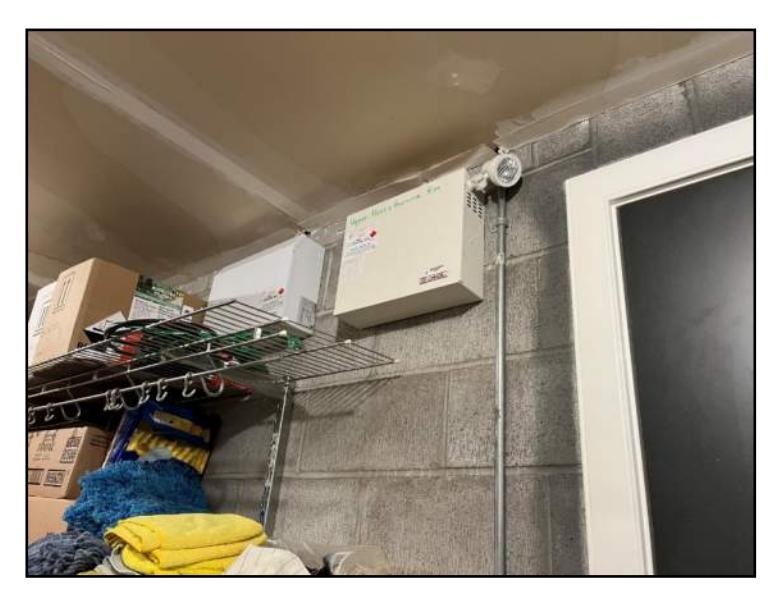
Photo 2.6.3.1-1 Typical remote head emergency light

Photo 2.6.3.1-2 Emergency lighting battery packs

We recommend you plan to replace the batteries and the light fixtures at the end of the component's useful life. We expect individual replacements will be completed as needed as part of regular maintenance.

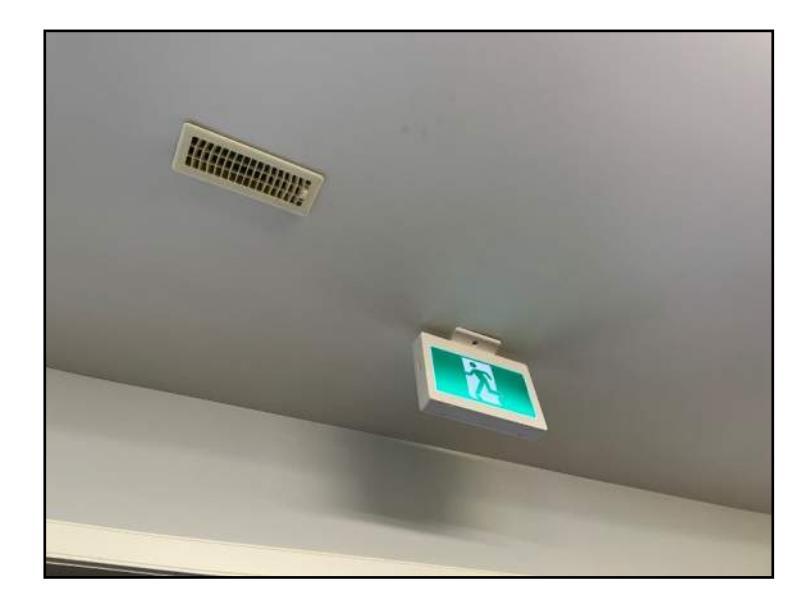
Photo 2.6.3.2-1 Exit sign at Lake House

We recommend you plan to replace the exit signs at the end of the component's service life. Given the limited amount, we expect that individual replacements will be completed as needed, as part of regular maintenance.

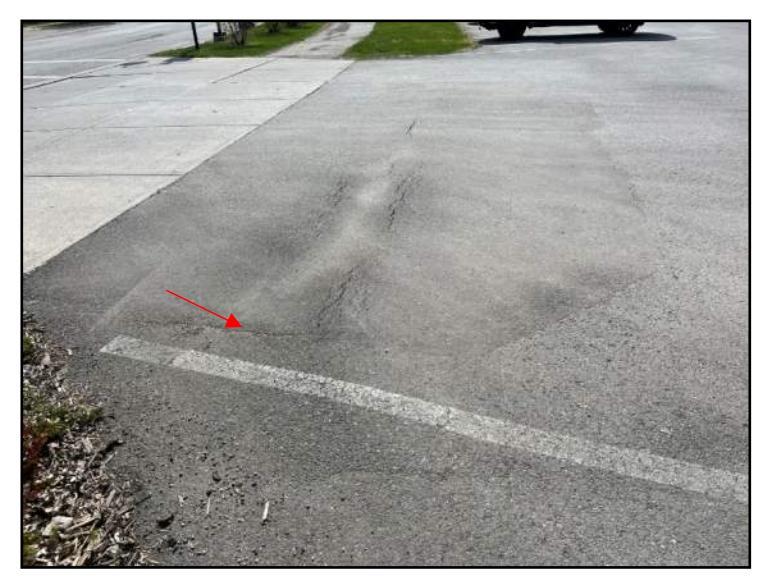
Photo 2.7.1.1-1 Local dense cracking and settlement at asphalt parking lot

We recommend you plan for replacement of the asphalt at the end of the useful life for this component. As this is beyond the report term, a replacement budget has not been included in Table 1.

In the interim (between full replacement projects), we recommend budgeting for local repairs to address problem areas (i.e., extensive settlement, heaving, or potholes). A periodic asphalt paving repair allowance has been included in Table 1. Long cracks can be hot pour-sealed as part of ongoing maintenance or out of this allowance. The first occurrence of this allowance has been included in the near term to help address the settlement / heaving causing water ingress to the garage.

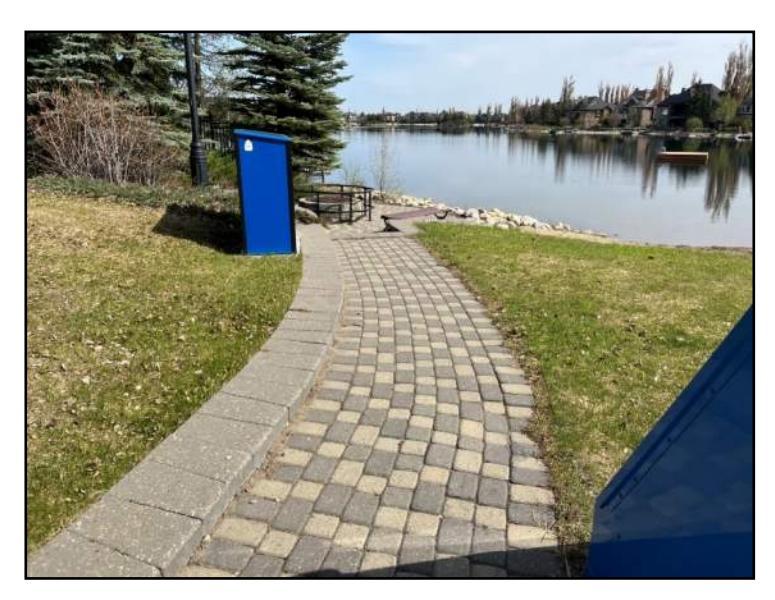
Local minor settlement was noted at the unit pavers.

Photo 2.7.1.5-1 Interlocking concrete unit pavers to fire pit

We recommend you plan for replacement of the unit pavers at the end of the component's service life. As this is beyond the report term, a replacement budget has not been included in Table 1.

Interlocking unit pavers typically require periodic local re-setting and replacements in between general replacement. A periodic allowance has been included in Table 1 to re-set the pavers.

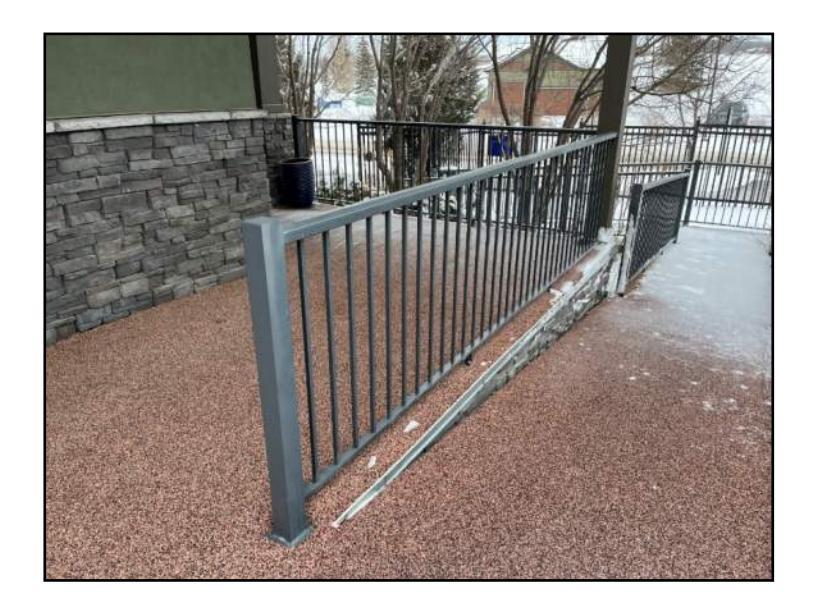
Peeling finish was noted locally.

Photo 2.7.2.1-1 Typical guard rail at Lake House

We recommend you plan for replacement of the guards at the end of the component's useful life. A replacement budget has been included in Table 1. Timing has been adjusted slightly to coincide with replacement of the deck waterproofing (see Section 2.1.2.3).

If needed, local repairs and touch-up painting are anticipated to be completed as a maintenance activity.
