Lifecycle Assessment Report

The Lake at Heritage Pointe Owners Association

Heritage Pointe, Alberta

Report No. 2300676.00

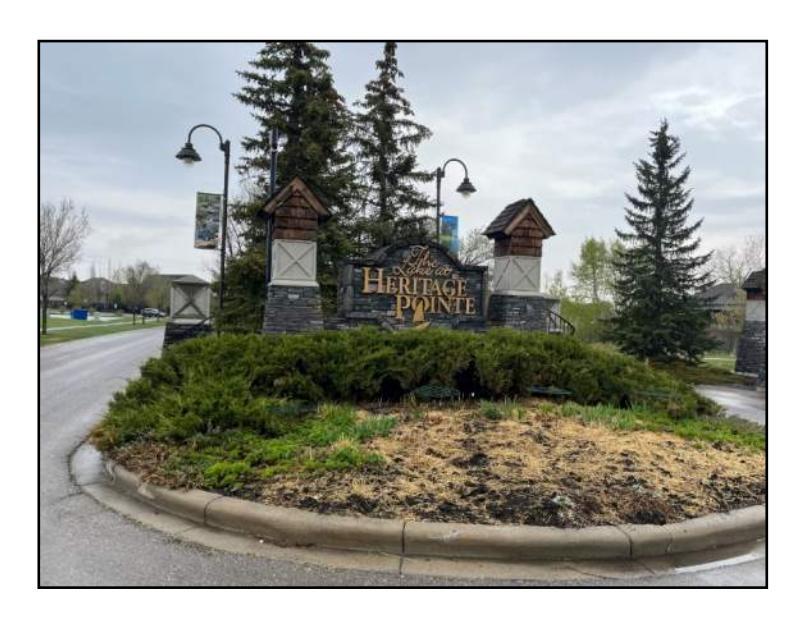
We noted vegetation growth at the stone cladding at the south entrance sign and some of the street entrance signs. Peeling paint was noted at the wood fascia at the south entrance sign.

Photo 2.7.3.1-1 Stone-clad sign at south entrance

We recommend you plan to replace the various signs at the end of the components' useful life. Budgets have been included in Table 1 for signs that are expected to reach the end of service life within the report term.

Local repairs including cleaning the stone cladding, repair and repainting the wood "roofing", and local replacement of letters are expected to be completed as needed as part of regular maintenance.

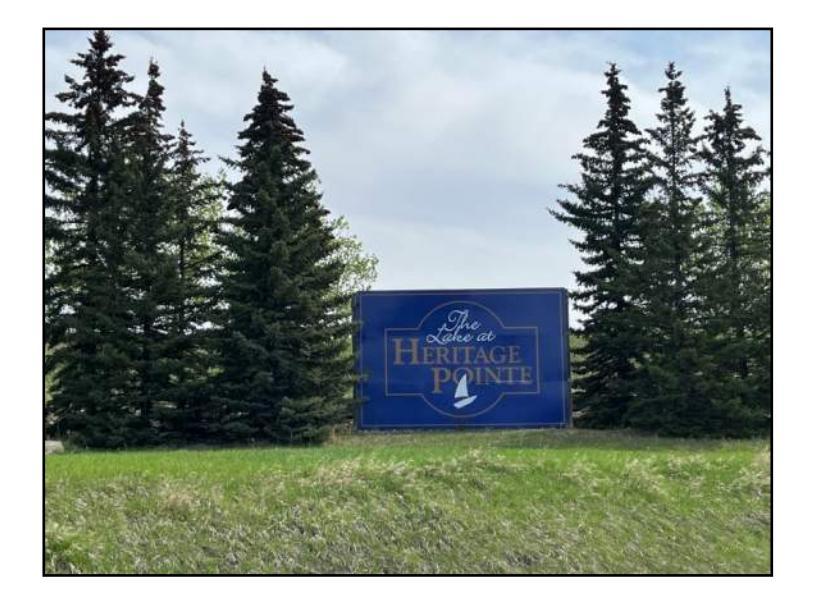
Photo 2.7.3.1-2 Billboard sign

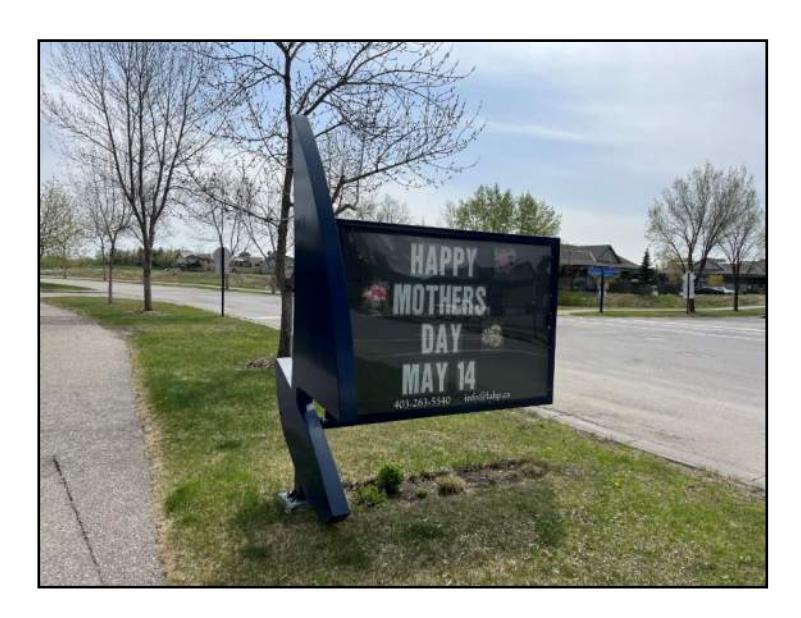
Photo 2.7.3.1-3 Community and Events sign

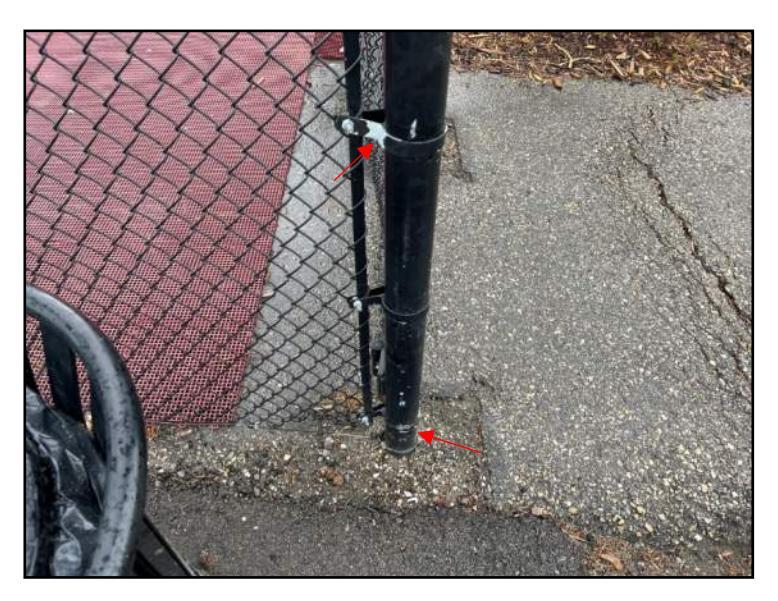
Peeling finish and local detachment at the base of fence posts was noted.

Photo 2.7.4.1-1 Peeling finish at chain link fence

We recommend you plan to replace the chain link fence and gate at the end of the component's useful life. A budget has been included in Table 1.

We assume local repairs and touch-up painting will be completed as needed as part of regular maintenance.

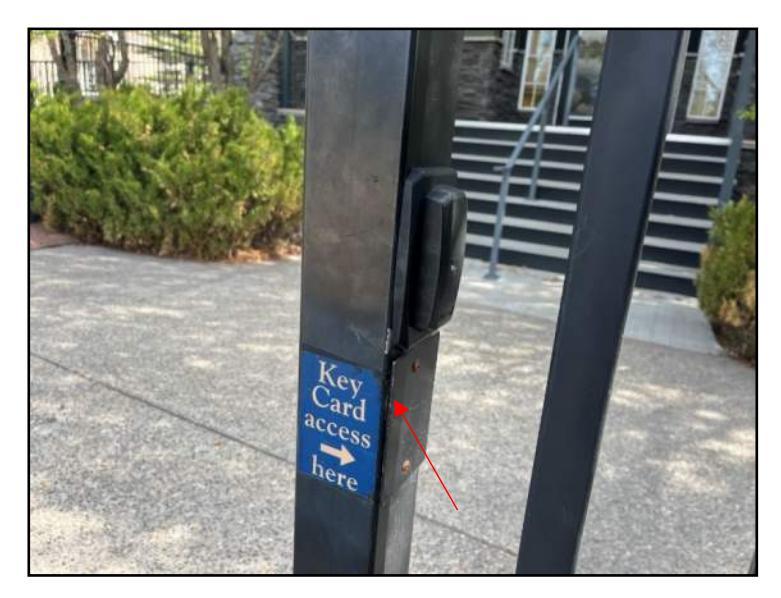
Photo 2.7.4.2-1 Chipped fence finish

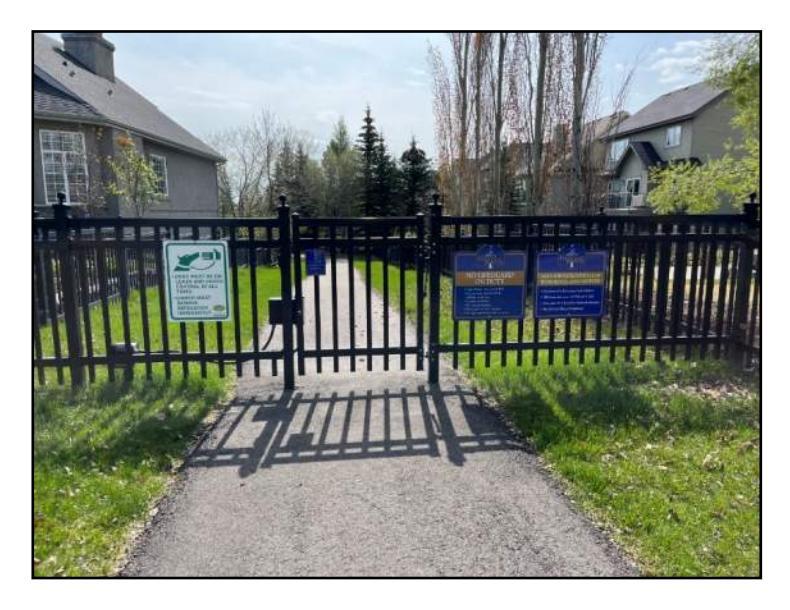
Photo 2.7.4.3-1 Typical gate access to lake

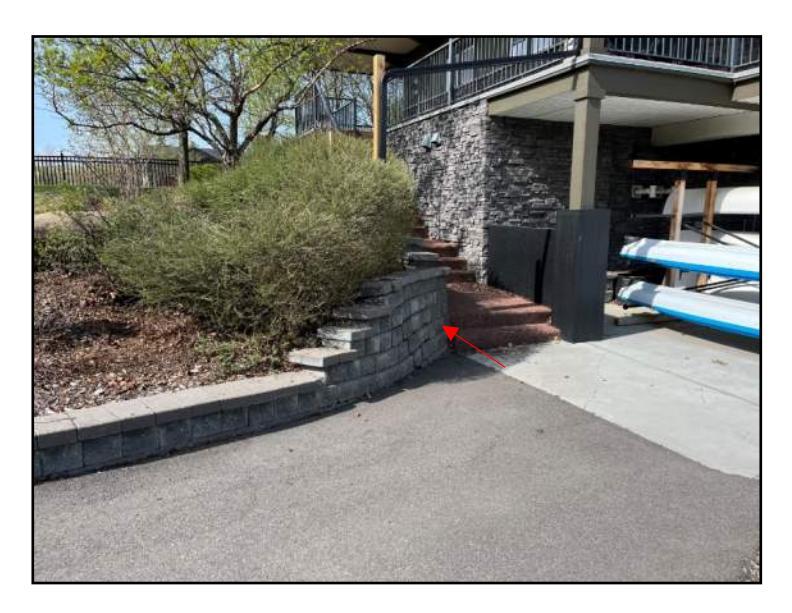
Photo 2.7.5.1-2 Evidence of movement at retaining wall

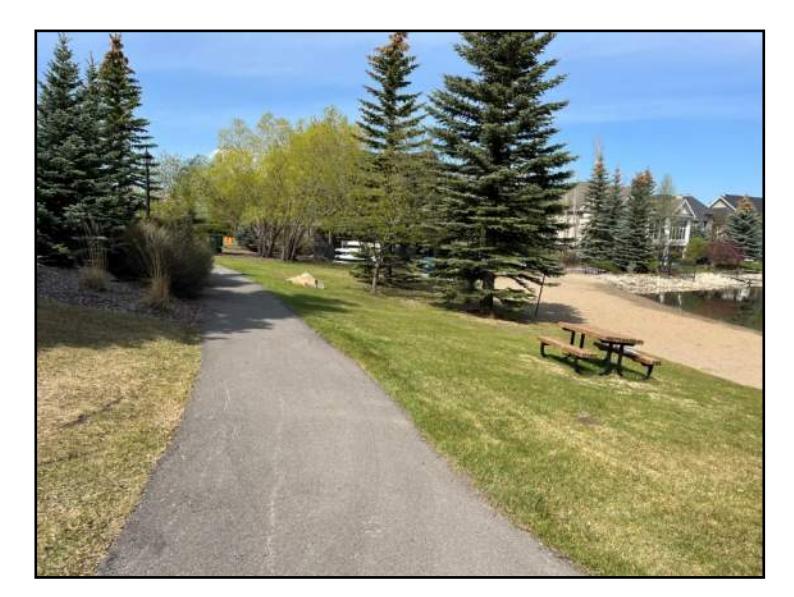
Photo 2.7.6.1-1 Typical shrubs and trees

We understand landscaping is maintained by the LAHPOA as part of regular maintenance, and we assume this practice will continue.

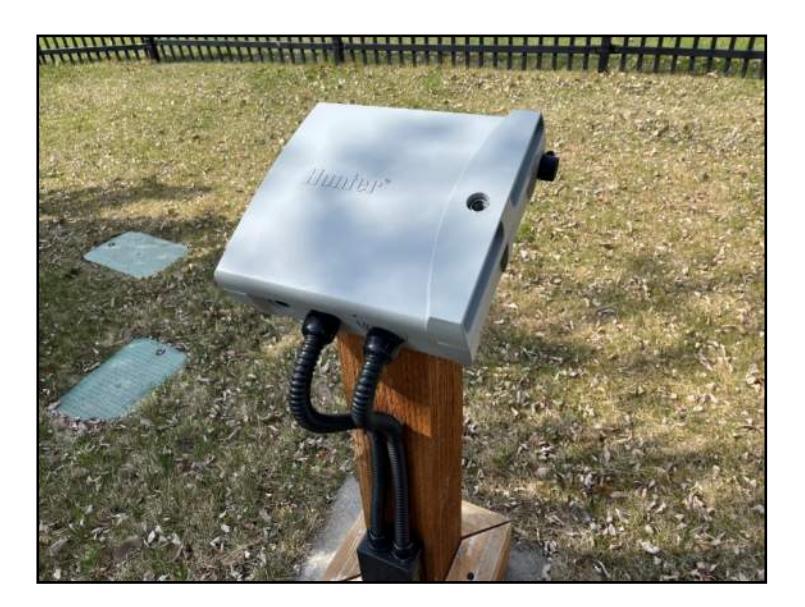
It was reported the irrigation system has undergone major repairs and upgrades over the last five years at a cost of approximately \$58,000. Two zones remain to be repaired in 2023. Since repairs have been completed to most of the system, the system was reported to be in good working condition.

Photo 2.7.7.1-1 Typical irrigation controller

We recommend you budget for annual repairs or replacement of isolated components. An allowance has been included in Table 1 accordingly. Spring start-up and fall shut-down costs have not been included in this repair allowance and are assumed to be completed as part of regular maintenance.

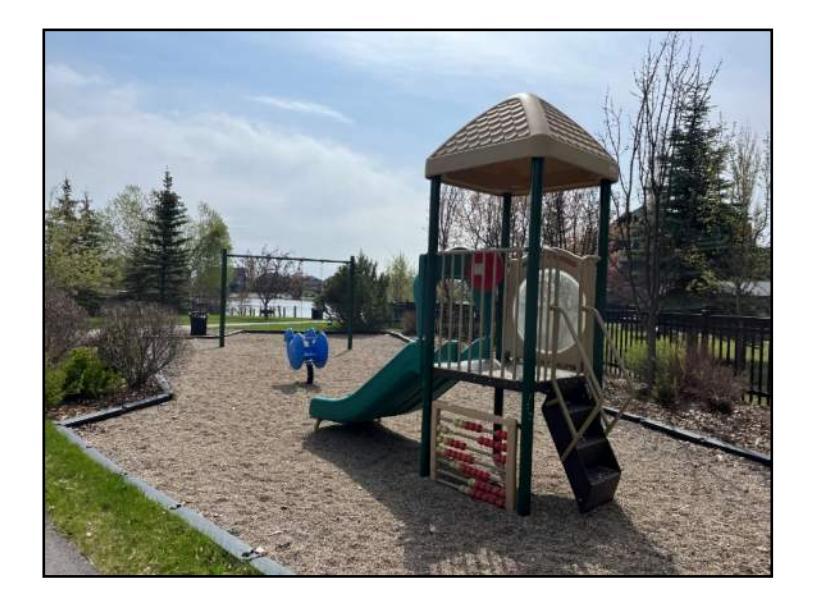
Photo 2.7.8.2-1 Typical playground equipment

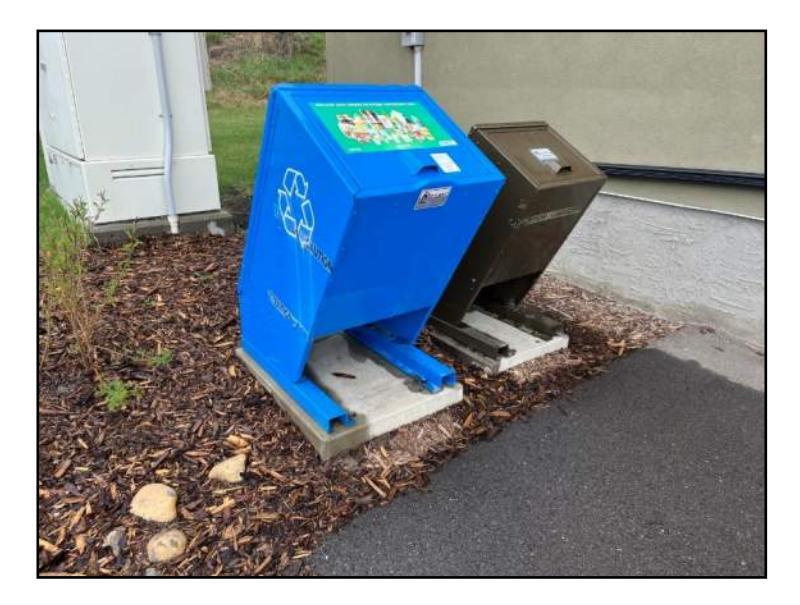
Photo 2.7.8.3-1 Metal recycling and waste bins

We recommend you plan to replace the various types of waste and recycling bins at the end of the component's service life. Replacement budgets have been included in Table 1. The replacement budget for the plastic bins has been included in a phased manner, per budgets provided by the Association.

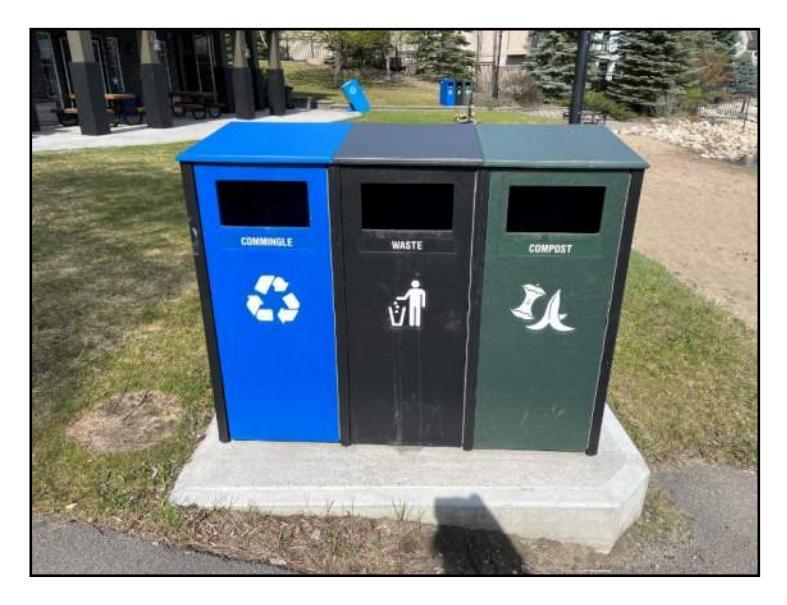
Photo 2.7.8.3-2 Composite waste collector

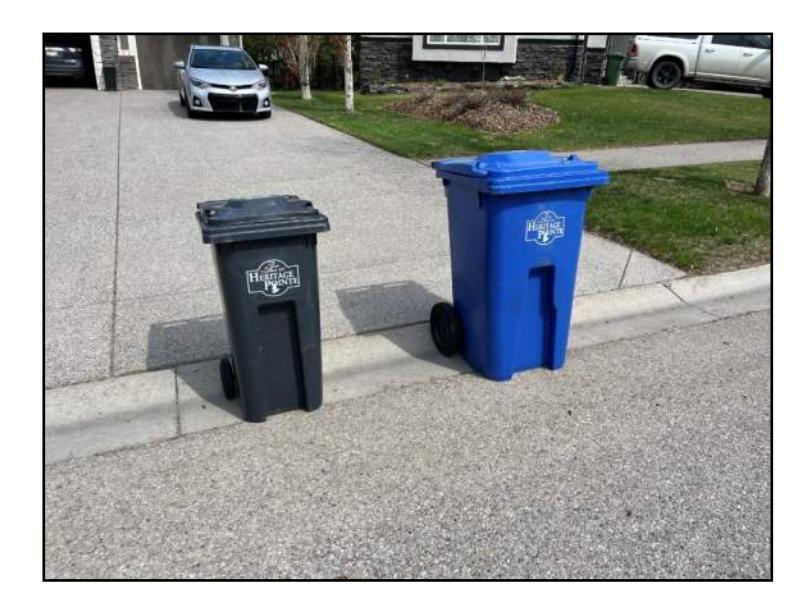
Photo 2.7.8.3-3 Plastic recycling and waste bins

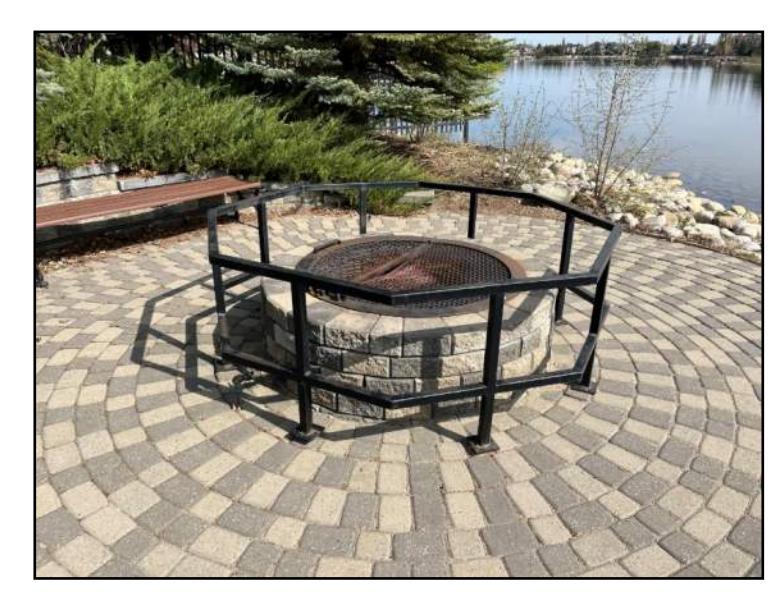
Photo 2.7.8.4-1 Natural gas fire pit

We recommend you plan for replacement of all fire pit components and the burner at the end of the components' useful life. Replacement budgets have been included in Table 1. We expect the grille can be replaced as needed at a cost below the capital expense threshold.

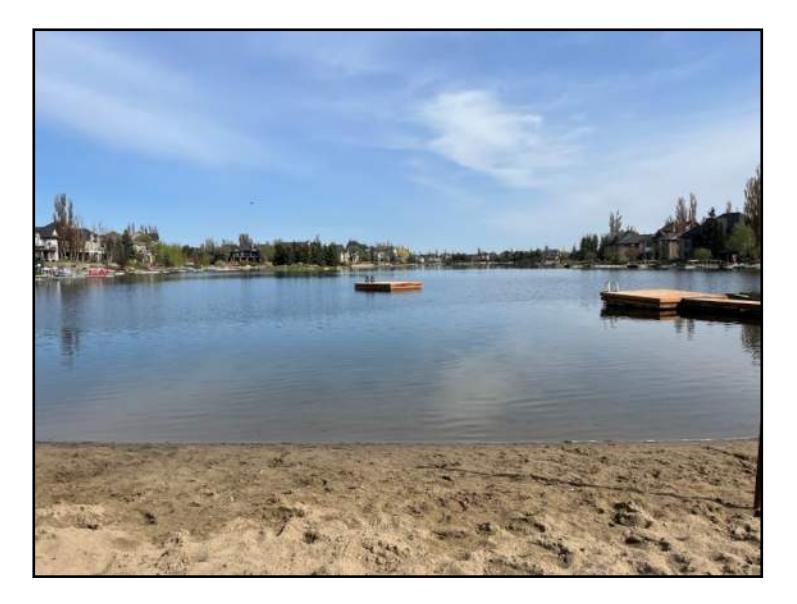
Photo 2.7.9.1-1 Lake

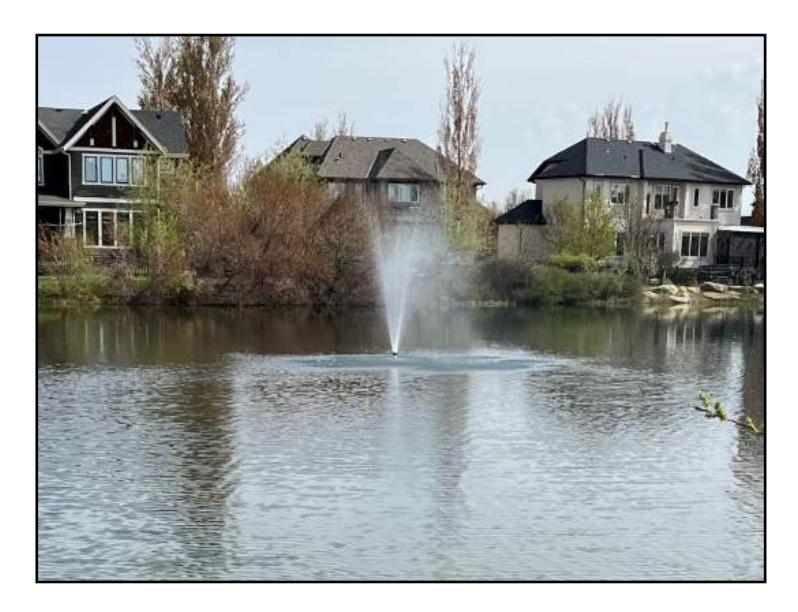
Photo 2.7.9.5-1 Lake

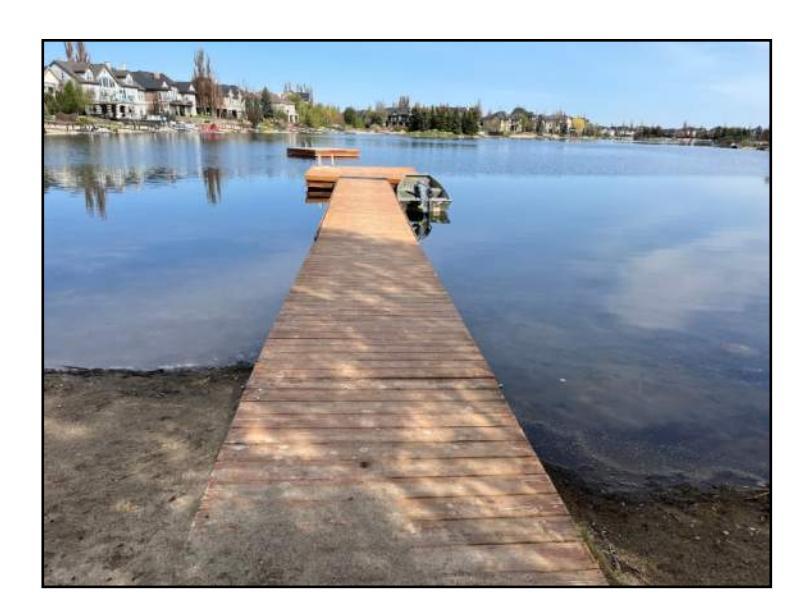
Photo 2.7.9.6-1 Stationary dock at Lake House

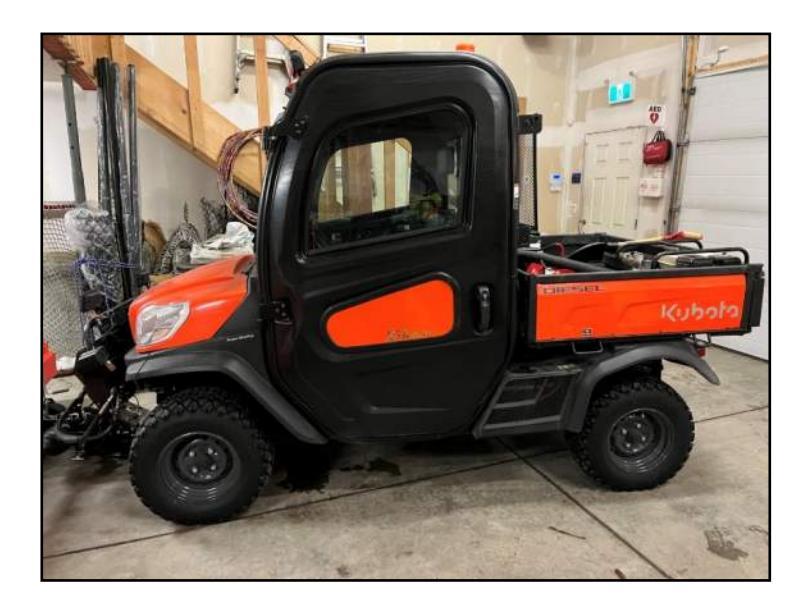
Photo 2.8.1.1-1 Kubota side-by-side

We recommend you plan to replace the landscaping equipment at the end of the component's service life. Budgets have been included in Table 1. The LAHPOA board provided much of the information related to the above equipment, including estimated service lives and estimated replacement budgets.

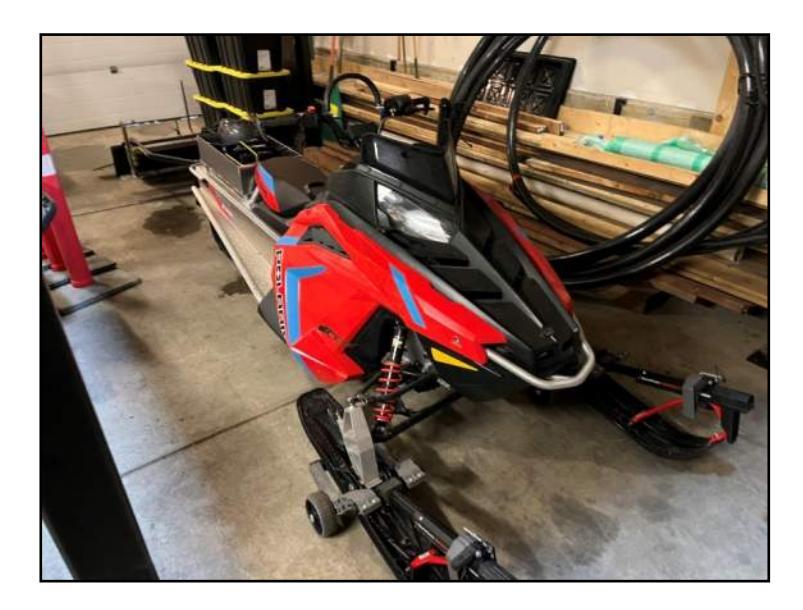
Photo 2.8.1.1-2 Snowmobile

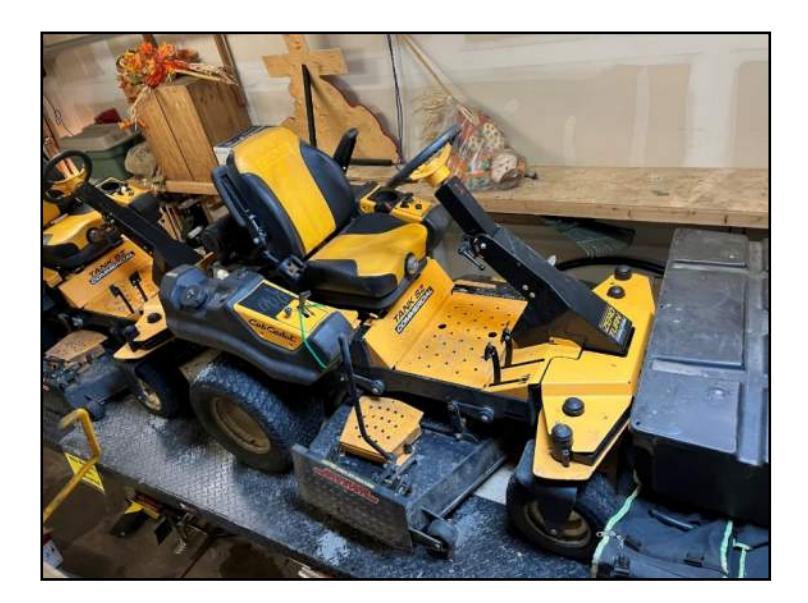
Photo 2.8.1.1-3 Club Cadet ride movers

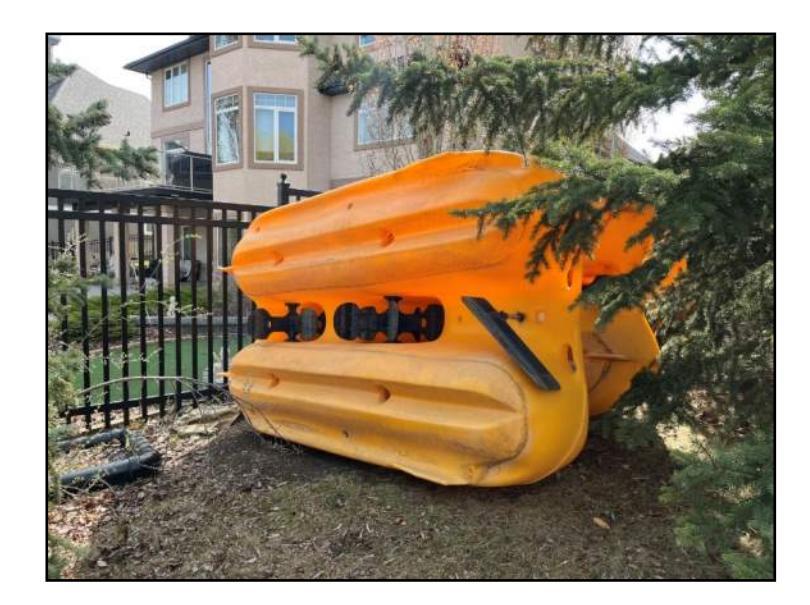
Photo 2.8.2.1-1 Peddle boats

We recommend you plan to replace the aquatic sporting equipment at the end of the components' service life. Budgets have been included in Table 1. The LAHPOA board provided much of the information related to the above equipment, including estimated service lives and estimated replacement budgets.

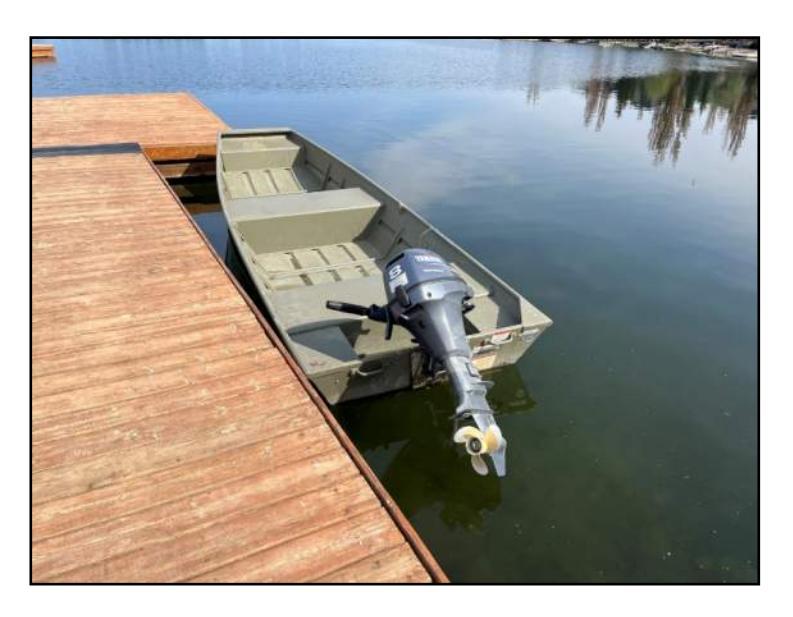
Photo 2.8.2.1-2 Aluminum boat and motor

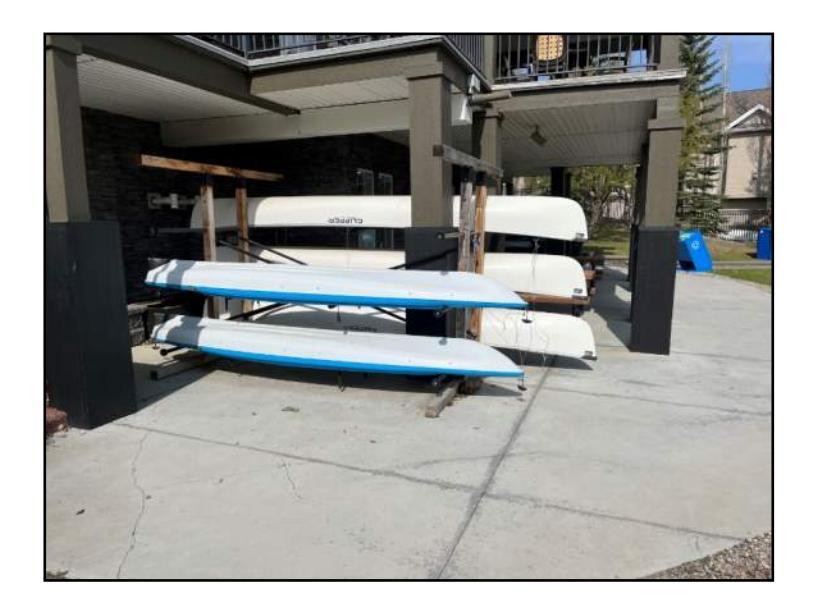
Photo 2.8.2.1-3 Canoes and kayaks
